## INCIDENT ALERT

**LOCATION:** READYMIX OR MORTAR PLANT  
**ACTIVITY:** TRANSPORT / DELIVERY  
**SUB ACTIVITY:** MOBILE PLANT

**ALERT STATUS:** Normal  
**DATE ISSUED:** 12/12/2011  
**INCIDENT No:** 00318

**Truck Mixer Driver Fall**

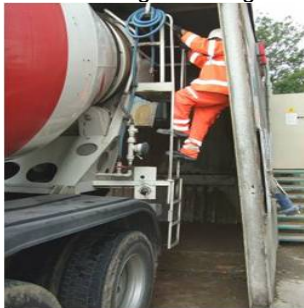
Climbing up to the access platform, the driver coiled away the hose and then started to descend the ladder. During this descent his foot slipped off the 5th rung of the ladder (measured at 1.6m from ground level). As he fell to the ground, he landed heavily on his right foot, chipping a bone in his ankle; not only was he in some pain, being self employed he is now unable to work for several weeks.

**Position from where driver fell**

- The Driver had washed down his vehicle, in the rain, using a detergent:
  - are employees and contractors using the correct industrial cleaning agents to ensure work surfaces and equipment are suitably cleaned, without leaving a slippery film on the surfaces?

- The swing bar was bent out of shape causing it to close below its fixing bracket:
  - do we have robust inspection systems in place to ensure this type of defect is identified and corrective action taken?

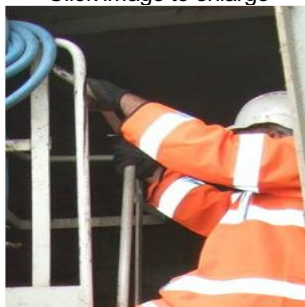
- As he descended the ladder, instead of holding onto both vertical hand rails he used the swing bar as one of his 3 points of contact:
  - Are employees and contractors reminded of the need to GET a GRIP, and maintain three secure points of contact when using ladders and stairways? Is this monitored by site supervision? In this case, the Driver relied on the self closing gate as a point of contact. Have we explained that hinge mechanisms on self closing gates and swing bars should not be used as hand holds? They can easily fail and, as happened in this incident, can cause a person to lose their grip and fall.

**Renactment showing driver holding swingbar**

- Records indicate that the driver had not received GET a GRIP training for over three years:
  - Do we regularly remind employees and contractors of key health and safety messages, for example in this case by inviting them to attend Drivers Safety Workshops, the Drivers Handbook briefings and New Year back to work training sessions?
