Operator injures foot while replacing the cutting edge on loading shovel bucket

ALERT STATUS: Normal
DATE ISSUED: 23/02/2021 20:21:41
INCIDENT No: 03587

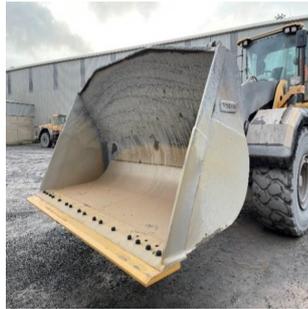
After - Bucket with new edge fitted
