Dumper Driver Crush Injuries

LOCATION:	CEMENT PLANT
ACTIVITY:	MAINTENANCE & HOUSEKEEPING
SUB ACTIVITY:	N/A

ALERT STATUS:	Normal
DATE ISSUED:	18/02/2013
INCIDENT No:	00359

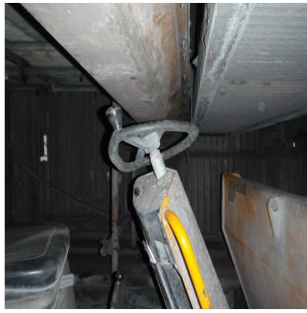
Dumper Close Up

The driver had transported one load of sweepings to a recycling point and was carrying out a three stage manoeuvre in the building to position the skip under the fixed chute. Whilst reversing he lost control of the vehicle, travelling further back than intended and became crushed between the dumper steering wheel and the casing of an inclined screw conveyor directly above him. He received injuries to his chest and knee.

The driver said that he could not stop the vehicle because the brakes had failed. Two independent engineers could not find any defects with the brakes or drive system.

The vehicle roll over protection bar had been folded down to access the building but had not been put back up once inside: Whilst not designed to protect against this type of incident, in this case it would have prevented injury. Are drivers trained to return the roll bar to the correct position as soon as possible?

There was limited space to manoeuvre the dumper to position the skip under the chute: Do we consider methods of work that avoid the need to take vehicles inside buildings? Are specific risk assessments carried out and control measures applied for the use of vehicles inside buildings or in restricted spaces? Are teams trained in these assessments and are the controls enforced through supervision? Are vehicles suitable for use in buildings?

The driver was experienced and had recently completed refresher training in the use of the vehicle: however, he lost control of the vehicle in

an environment where he would have been expected to be exercising caution. Are regular driver assessments carried out to identify if driver behaviours demonstrate that competency standards are maintained? Is there sufficient Supervision to ensure work activities are undertaken safely at all times?

Daily checks had been carried out: Whilst not contributing to the incident, there were minor defects on the vehicle. Are there effective inspection and defect reporting procedures? Are there rules in place to guide supervisors to remove and prevent the use of defective vehicles?
