Fatal 5 - Readymix discharge cone and frame weighing 350 kg fall during cleaning operation due to mechanical failure

ALERT STATUS: High Potential
DATE ISSUED: 14/03/2024 17:04:45
INCIDENT No: 03700

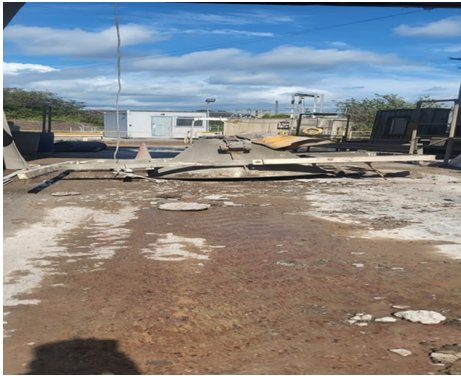
Initial investigations indicate that the split pins had sheared off the pivot point, combined with possible distortion in the frame, which allowed movement and the frame to detach from the pivot point. Fortunately, the Plant Manager was not in the line of fire when the failure occurred. Image below shows discharge cone and lifting frame on the ground.

Preventative maintenance - It is believed the split pins on the pivot end of the frame had sheared off through wear and tear and regular lowering of the frame assembly.

- Ensure maintenance regimes are effective and all load bearing parts of equipment such as pivot hinges are subject to routine inspections in accordance with manufacturer's specification.
- Split pins must be checked for wear to ensure equipment remains in alignment.
