Fatal 6 - A vehicle loses rear wheels whilst on- highway having recently had its brakes serviced - the incident has been caught on video

LOCATION:	ON-HIGHWAY	ALERT STATUS:	Normal
ACTIVITY:	TRANSPORT & LOGISTICS / DELIVERY	DATE ISSUED:	11/09/2024 17:36:30
SUB ACTIVITY:	TYRES AND WHEELS	INCIDENT No:	03760

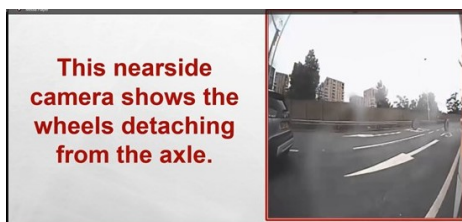
- Unfortunately, one or more of these processes were not completed to the required standard and when the vehicle was travelling along a dual carriageway in London, two of the nearside rear wheels detached from the same axle of the truck.

In the image below you can see the two wheels rolling over the white markings in the road.

This incident highlights the importance of vendors following the correct procedures regarding torquing and re-torquing wheel nuts after a wheel has been removed.

- **ALWAYS** ensure wheels are retorqued in accordance with the relevant guidance and only using approved / accredited vendors.
- **ALWAYS** complete your vehicle Walk Round Check at the start and end of shift and if work has been carried out on your vehicle, especially after wheels have been removed.
- **ALWAYS** check wheel nut indicators are in the correct position around the vehicle wheels.
- **PERIODICALLY** remove the Wheel Nut Indicators and check for visible signs of loose wheel nuts, visible rust around the studs or odd shaped stud holes on the drum.
- **ALWAYS** report any findings to your line manager before moving onto a public highway, don't risk your or anyone else's life.
