## INCIDENT ALERT

<b>LOCATION:</b>	<b>MOBILE PLANT</b>	<b>ALERT STATUS:</b>	<b>Normal</b>
<b>ACTIVITY:</b>	<b>MAINTENANCE &amp; HOUSEKEEPING</b>	<b>DATE ISSUED:</b>	<b>15/02/2014 08:00:57</b>
<b>SUB ACTIVITY:</b>	<b>N/A</b>	<b>INCIDENT No:</b>	<b>00377</b>

**Hydraulic injection injury to hand and arm whilst using a hand held grease gun**

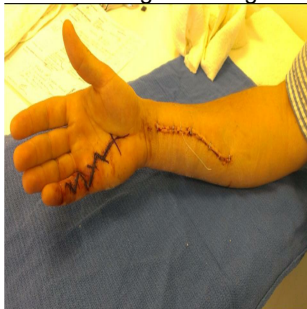
An operator was attempting to remove a hand grease gun from a grease nipple after pumping several times and finding it hard. Whilst gripping the hose and manoeuvring it, the hose ruptured and injected grease into his little finger.

He only felt a sharp prick to his little finger and on inspection, he noticed a small hole. On squeezing his finger approximately one teaspoon of grease was ejected. He was not wearing gloves at the time.

- Inspect equipment prior to use to ensure it is in sound working order with no cuts or damage.
- Check and tighten fittings
- Wear suitable protective gloves when using any equipment with stored energy potential.
- Even relatively low pressure equipment has the potential to inflict hydraulic injection injury
- Grease gun hose was not a strengthened hydraulic pressure (woven/mesh) type but of a rubberised compound only.
