## INCIDENT ALERT

<b>LOCATION:</b>	<b>COMPANY-WIDE</b>	<b>ALERT STATUS:</b>	<b>Normal</b>
<b>ACTIVITY:</b>	<b>MAINTENANCE &amp; HOUSEKEEPING</b>	<b>DATE ISSUED:</b>	<b>08/01/2015 18:31:11</b>
<b>SUB ACTIVITY:</b>	<b>N/A</b>	<b>INCIDENT No:</b>	<b>00397</b>

**Fitter Struck by Grinding Wheel**

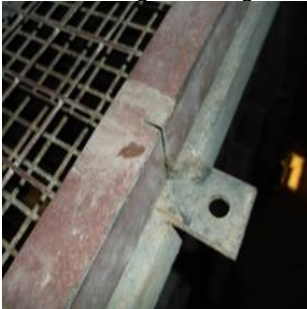
**Guarding Being Cut**

- The guard was not clamped securely and moved when the grinder was applied. Are there suitable maintenance facilities on site for the range of activities being undertaken? Are work pieces suitably supported / secure, being clamped or held in a vice where possible?

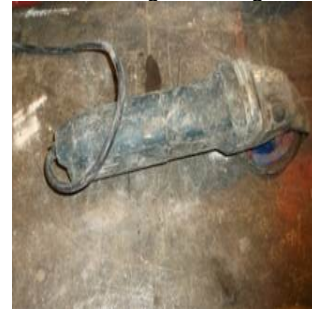
**Angle Grinder**

- The grinder did not have handle attached and it kept running when the Fitter lost his grip due to the power switch remaining engaged. The defect reporting system for powered hand tools was not being used at the site. Do you use the right, well maintained, tools / equipment for the job and never make do? Do you have adequate defect reporting and inspection systems for tools and machinery? Do powered hand tools have hold to run controls that cut the power when released?

- Though having received training, the Fitter was using the wrong disc for the activity being undertaken. Are personnel trained, competent and authorised for the full range of tasks they are required to carry out? Do they apply this training in the use and selection of the work methods and equipment they use?

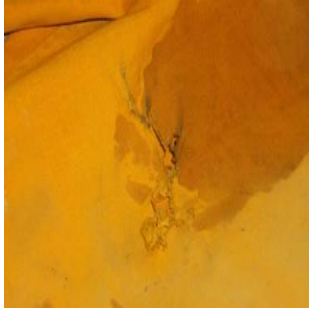
This caused a cut to the Fitter's leg which required hospital attention and six stitches. The Fitter had completed a pre-job Worksafe Assessment prior to the task.

**Fitters Overalls**
