INCIDENT ALERT

LOCATION: LIME & SLAG PLANTS
ACTIVITY: ACCESS & EGRESS & WORKING AT HEIGHT
SUB ACTIVITY: N/A

ALERT STATUS: Normal
DATE ISSUED: 24/02/2015 10:29:32
INCIDENT No: 00404

MEWP Near Miss

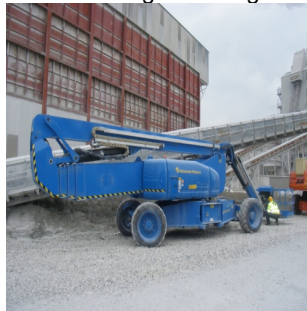
The operator took the machine up to the working area (27metres), once the platform had reached the required height, he took his hands off the controls and the foot pedal; at this point the boom and basket continued to move. He hit the emergency stop and it still continued to move eventually becoming wedged between the kiln sheeting and skip hoist structure, the guardrails of the platform as result of it becoming snagged on the structure was damaged.

MEWP

- In future, it shall be mandatory that all operatives of MEWPS shall wear a work restraint harness, connected to an anchor point on the MEWP basket.

- Always insist on a familiarisation of the machine controls etc. include also in the familiarisation, another person who is able to operate the machine, using ground controls for rescue.

- Ensure that the risk assessment always includes an emergency and rescue procedure.
