Operator's arm lacerated when a power tool he was carrying was unintentionally activated

LOCATION:	QUARRY	ALERT STATUS:	Normal
ACTIVITY:	POWER TOOLS AND BATTERY SAFETY	DATE ISSUED:	02/10/2024 12:53:38
SUB ACTIVITY:	NO SUB ACTIVITY AVAILABLE	INCIDENT No:	04836

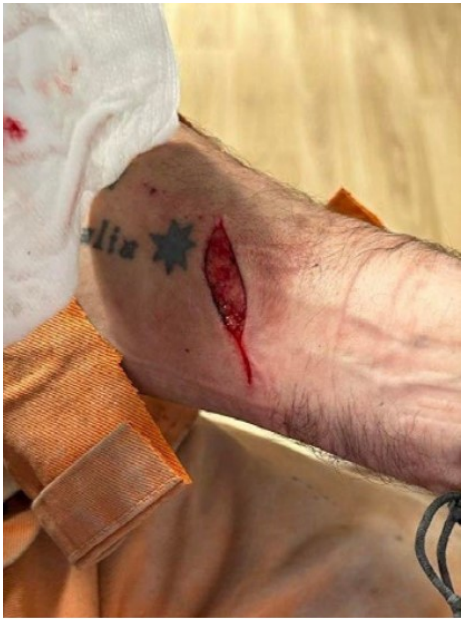
IP was assisting the fitter, after task had been completed, by helping clear tools and waste away from work site. This included bolts, hand tools and a battery operated 'angle grinder'. As they were carrying these items, by using both arms and cradling toward their chest, it is understood that the grinder activated cutting into his lower left forearm.

An investigation concluded the following as root causes of the incident.

- No record of inspection
- Failure to prepare work area and assess risk
- Lack of management control

For every non routine task a take one or point of work risk assessment MUST be carried out involving all parties (employee/contractor).

- Only competent operators to handle power tools.
- Ensure all tools (company or contractor) are inspected before use. Those found with defective safety devices/features are to be removed from service immediately.
- Consider Isolation during transportation (remove battery/unplug) in RAMs when using power tools.
- All tools are to be stored and transported to and from the place of work in an appropriate container.

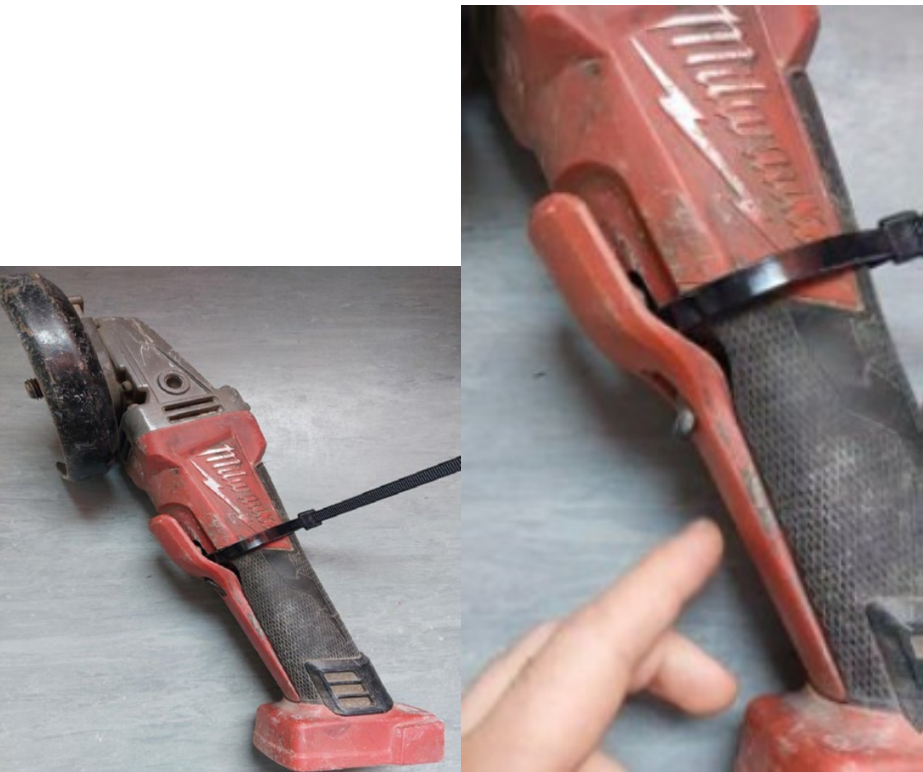
Images below show the tie that was added to grinder during the investigation.
