# Operator's arm lacerated when a power tool he was carrying was unintentionally activated

**LOCATION:** QUARRY  
**ACTIVITY:** POWER TOOLS AND BATTERY SAFETY  
**SUB ACTIVITY:** NO SUB ACTIVITY AVAILABLE

**ALERT STATUS:** Normal  
**DATE ISSUED:** 02/10/2024 12:53:38  
**INCIDENT No:** 04836

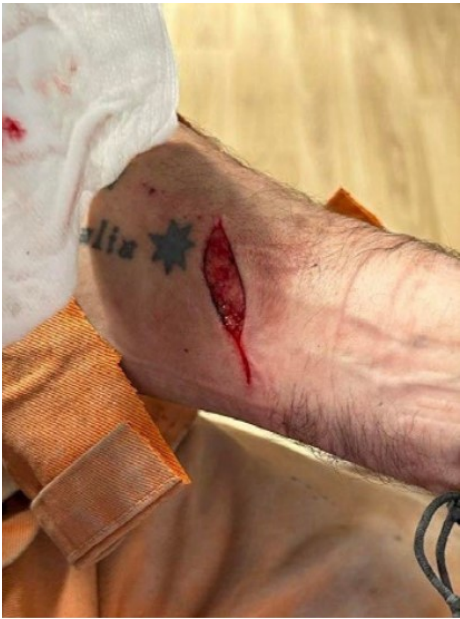
IP was assisting the fitter, after task had been completed, by helping clear tools and waste away from work site. This included bolts, hand tools and a battery operated 'angle grinder'. As they were carrying these items, by using both arms and cradling toward their chest, it is understood that the grinder activated cutting into his lower left forearm.

An investigation concluded the following as root causes of the incident.

- No record of inspection
- Failure to prepare work area and assess risk
- Lack of management control

For every non routine task a take one or point of work risk assessment MUST be carried out involving all parties (employee/contractor).

- Only competent operators to handle power tools.
- Ensure all tools (company or contractor) are inspected before use. Those found with defective safety devices/features are to be removed from service immediately.
- Consider Isolation during transportation (remove battery/unplug) in RAMs when using power tools.
- All tools are to be stored and transported to and from the place of work in an appropriate container.

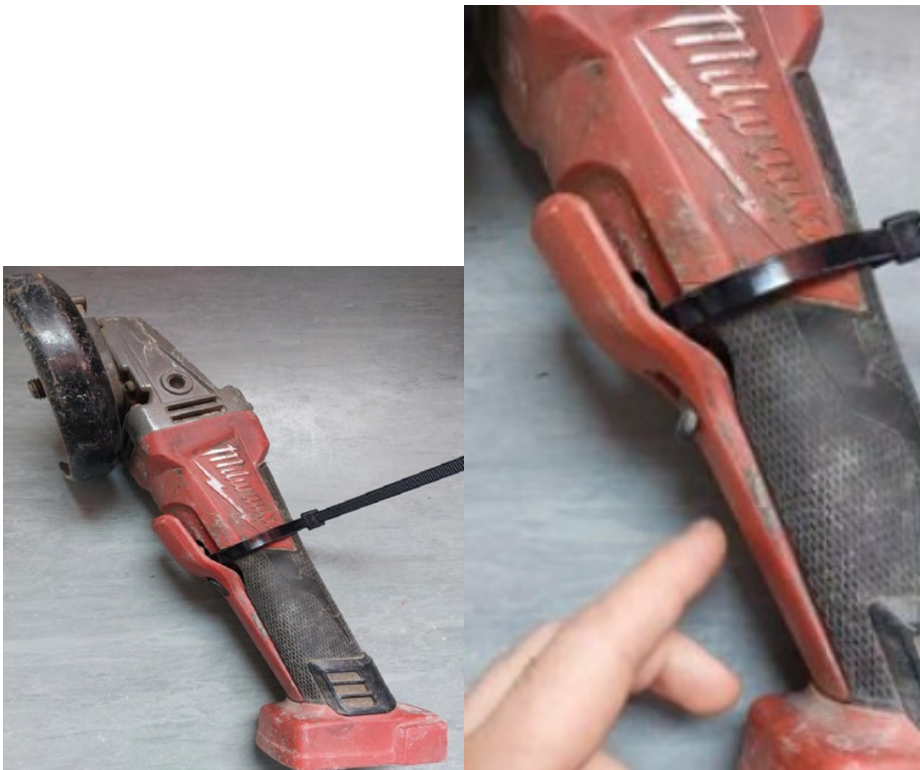
Images below show the tie that was added to grinder during the investigation.
