A contractor carrying out a quarry earthmoving campaign was required to cease operations and was expelled from the site on grounds of unsafe practices.

LOCATION: QUARRY
ACTIVITY: QUARRYING AND FACE ACTIVITY
SUB ACTIVITY: NO SUB ACTIVITY AVAILABLE

ALERT STATUS: Normal
DATE ISSUED: 17/03/2025 15:04:13
INCIDENT No: 04862

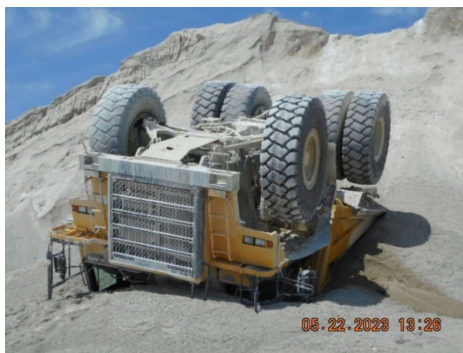
Please see below an example of **end tipping** that occurred in the USA. This incident resulted in a fatality.

Link to accident report: <https://www.msha.gov/data-reports/fatality-reports/2023/may-22-2023-fatality/final-report>
