Operator spots an incorrectly fitted D-Link prior to lifting operation, preventing potential for a failure in the lift and serious injury.

LOCATION: CONCRETE PRODUCTS PLANT
ACTIVITY: LIFTING
SUB ACTIVITY: NO SUB ACTIVITY AVAILABLE

ALERT STATUS: Normal
DATE ISSUED: 03/12/2025 18:18:37
INCIDENT No: 04955

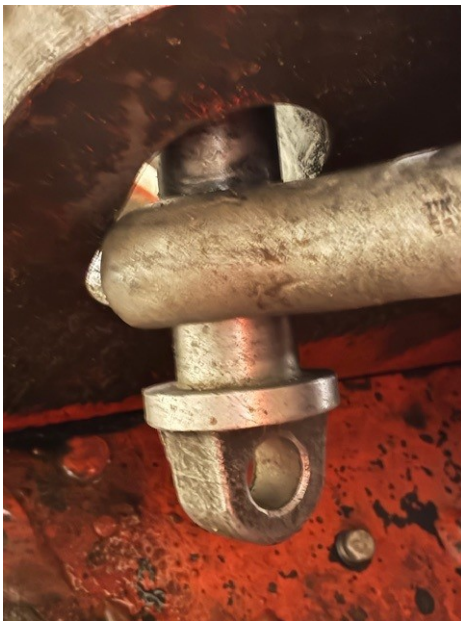
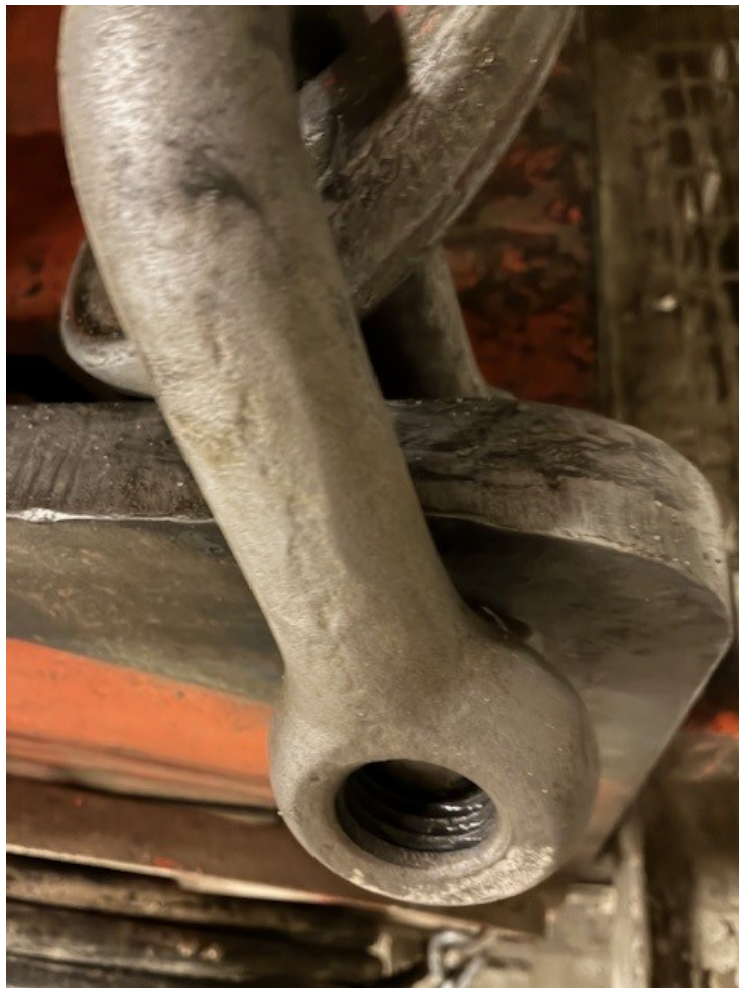
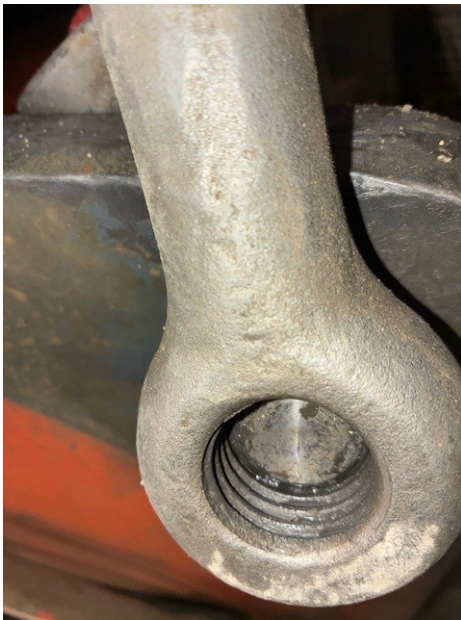
Whilst carrying out a pre-lift inspection, the operator noticed that a bolt on the D-link was not correctly fitted. Failure to spot and correct this could have resulted in a serious injury or fatality.

The images below show the pin for the shackle had not been properly secured with only a few threads engaged.

- Ensuring a D-Link (shackle or lifting link) is fitted correctly is critical to the safety and integrity of any lifting operation
- A D-Link connects lifting components such as slings, hooks, and loads, and must be properly aligned and secured to prevent failure under load.
- If fitted incorrectly, such as cross-loading the pin, using the wrong size or type, or failing to fully tighten and secure the pin – the link can deform or fail, resulting in dropped loads, equipment damage, or serious injury.
- Proper fitting ensures that the load is evenly distributed through the link, maintaining the rated lifting capacity and ensuring the lift proceeds safely and efficiently.
- Always inspect D-Links before use, confirm that they match the lifting plan specifications, and follow the manufacturer guidelines for installation.
