Fatal 1 – Contractor fails to follow isolation procedures whilst working on crusher putting himself at risk of sustaining a fatal injury

LOCATION: QUARRY
ACTIVITY: MAINTENANCE & HOUSEKEEPING
SUB ACTIVITY: CRUSHERS

ALERT STATUS: Normal
DATE ISSUED: 14/12/2025 20:29:28
INCIDENT No: 04960

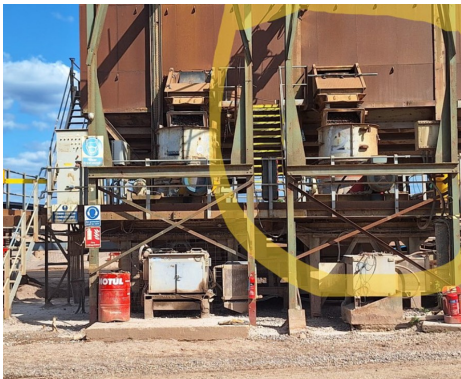
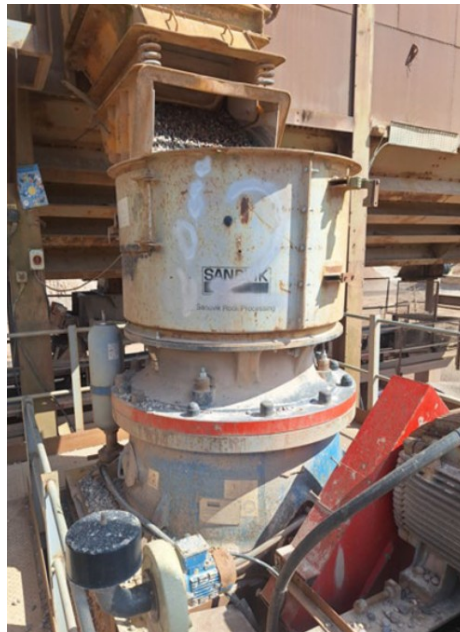
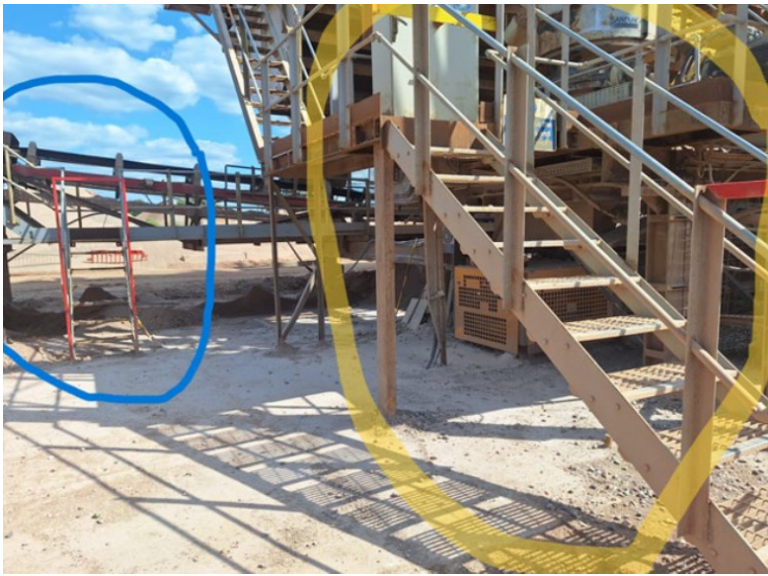
A contractor climbed into crusher to have a look at the skato plates as these were on the job list for the day. They were advised at the start of the day to return to the office after completing his first job for the isolation to be removed, the equipment for the next tasks would then be isolated, ready for working on. The contractor failed to follow the instruction and consequently, the crusher was not isolated when he entered.

Failure to identify hazards - Contractor did not check to see if crusher was isolated before climbing in to assess works required.

In the images below, the contractor's access to work area is in blue, access steps to the crusher are shown in yellow.

- All contractors to complete 9 Steps to LOTOTO video and comprehension test before any works are carried out
- Clear communication from site regarding sequence for multiple tasks
