Fatal 5 - Telehandler strikes mixer truck at a construction site.

ALERT STATUS: Normal
DATE ISSUED: 18/12/2025 12:44:55
INCIDENT No: 04964

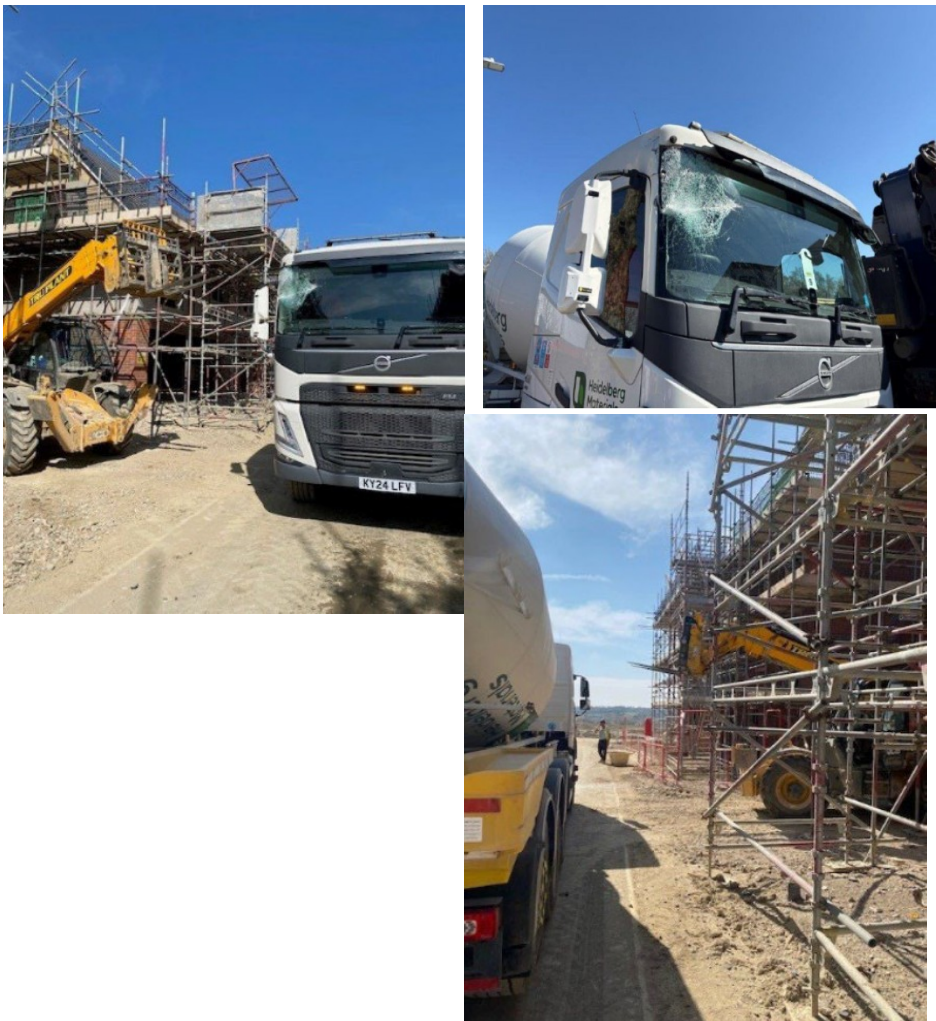
Due to restricted visibility caused by the surrounding scaffold, the operator of the telescopic handler did not observe an approaching concrete mixer vehicle. As a result, the telescopic handler made contact with the front driver's side of the mixer vehicle.

The incident resulted in damage to the windscreen of the concrete mixer truck.

- Restricted visibility of the telescopic handler exiting between two houses

The images below show the damage to the mixer and how the view was restricted by scaffolding

- Safety concerns raised with the Principal Contractor for site
- Raise awareness via this alert to the driver community
