# Fatal 2 - Front end loader (FEL) reversed into pedestrian pod.

**LOCATION:** RAILHEAD  
**ACTIVITY:** MOBILE PLANT OPERATION AND MAINTENANCE  
**SUB ACTIVITY:** NO SUB ACTIVITY AVAILABLE

**ALERT STATUS:** Normal  
**DATE ISSUED:** 18/12/2025 13:39:38  
**INCIDENT No:** 04965

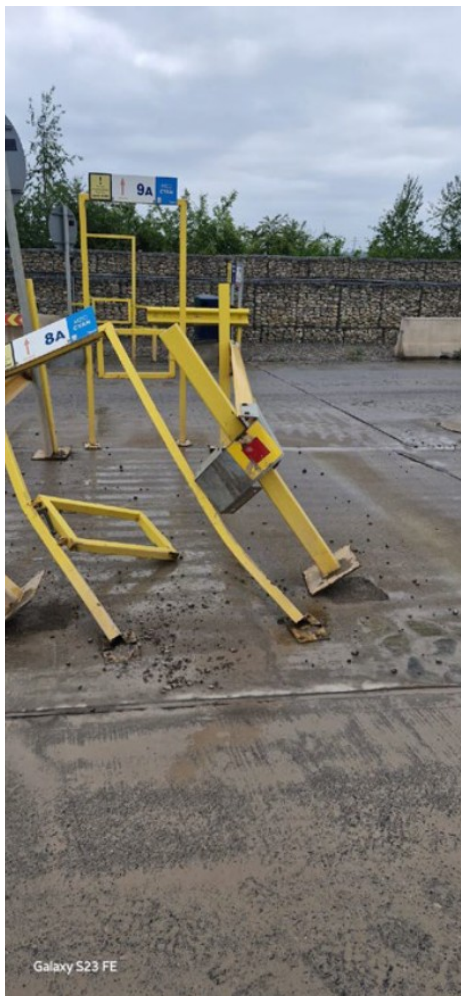
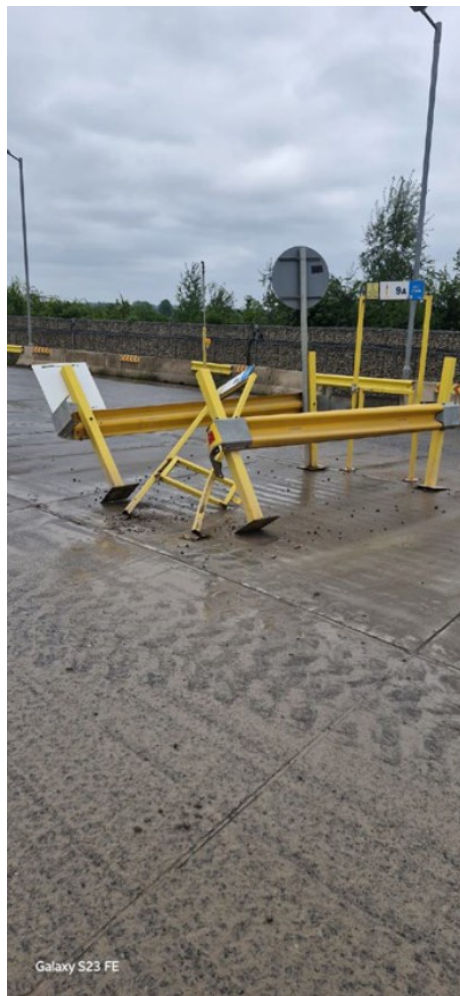
While performing an ad hoc task of moving concrete planters, a front end loader operator reversed into a pedestrian pod, damaging the Armco barrier and a pedestrian gate. There was no restricted access to the walkway or pedestrian crossing whilst this activity was taking place. A risk assessment had been completed by the site supervisor based on using one machine to move the planters but not a second FEL. The risk assessment had not identified the pedestrian pod as a hazard, and neither operator had been involved in the process.

- Insufficient identification of hazards during the creation of the risk assessment.

- Neither operator was directly involved in the risk assessment process and neither had identified that using a second machine was a significant change for which an additional risk assessment should have been completed.
- The operator was not fully concentrating on all elements of the activity as they were talking on the radio whilst reversing

- Risk assessment toolbox talk to be delivered to all site personnel.
- Site survey to review walkways and re-route them where possible.

- All machine operators must ensure the machine is in a safe position before using a radio, to maintain full focus and control during operation.
- All individuals involved in a task must actively participate in the risk assessment process to ensure shared understanding and accountability.
- Everyone involved in the task must read, understand, and acknowledge the relevant risk assessment or documentation before undertaking the task.
