BEST PRACTICE

LOCATION:	Mobile Plant	ARTICLE YEAR	2017
ACTIVITY:	Maintenance & Housekeeping	COMPANY:	Hanson UK
SUB ACTIVITY:	N/A	COMPANY LOCATION:	Barton Quarry
BEST PRACTICE No:	BP2003	COMPANY TEL:	07971 336578
COUNTRY OF ORIGIN:	United Kingdom

Emergency tyre deflation device

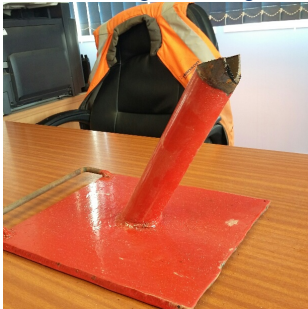
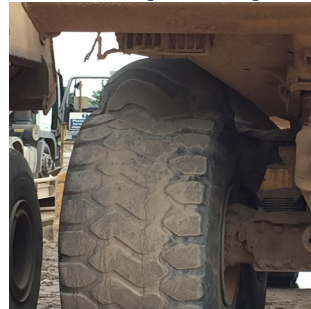
A failure on a tyre fitted to a Volvo ADT dumper caused the inner tube to balloon out of the casing. The tyre needed to be deflated, but due to the potentially weakened structure of the casing, removing the valve manually was not an option.

A spiked device was made consisting of a hollow tube welded to a plate with a hole in it to allow the air to escape. The device was then placed behind the tyre ready for use. Before commencing, a risk assessment and safe working practice was completed for the use of the device in consultation with the tyre company. A second ADT was used as a shield from any potential debris.

The ADT was then reversed onto the spike. This allowed the spike to pierce the tyre and safely deflate.
