BEST PRACTICE

Quarry
Worker Involvement
SSOW
BP2080

Bespoke moveable stop signs

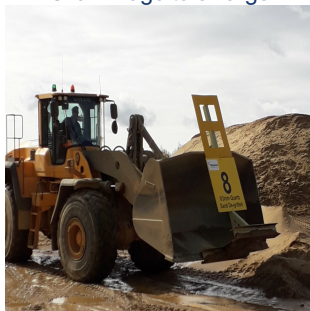
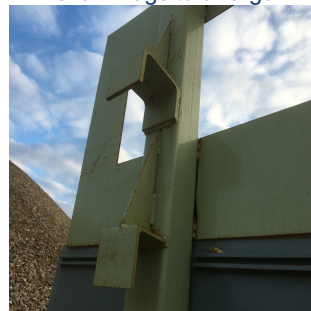
The sign can be lifted and placed into position by using a unique design that matches the measurements of the loading shovel buckets. It is picked up by placing the top lip of the loading shovel bucket in a bespoke notch welded to the upright and the bottom lip of the bucket into the lower angle of the bottom part of the base cross.

The numerical signs were cut from flat steel and painted to match the site QA dockets. The signs were placed on to the upright of a steel cross base.
