BEST PRACTICE

LOCATION:	Quarry	ARTICLE YEAR	2022
ACTIVITY:	Access & Egress & Working at Height	COMPANY:	Breedon Group
SUB ACTIVITY:	N/A	COMPANY LOCATION:	Leinthall Quarry
BEST PRACTICE No:	BP2179	COMPANY TEL:	0000
COUNTRY OF ORIGIN:

TITLE
Enhanced access & egress safety system for emergencies.
ARTICLE

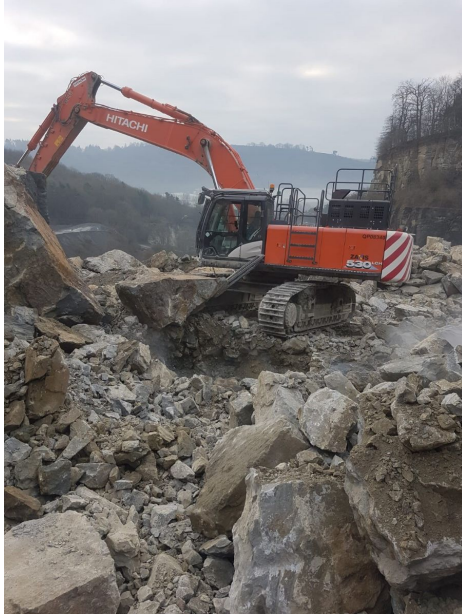
Excavator operative was working a blast pile, creating a bench and rock trap as required. Whilst carrying out this task, the operator decided to manoeuvre a large rock out of the way, which unfortunately naturally split. The top section of rock slid across the rock trap and hit the access platform of the Hitachi 530. The impact of this deformed the access system and the steps proximity switch had also been broken. This disabled the machine's ability to move from a potentially dangerous situation, e.g., further rock fall.

This occurrence has demonstrated the potential for an operator to not be able to track out of harm's way if such a system (access step proximity switch) is broken or breached. Currently they would rely solely on breaking cab glass and escaping, which could be deemed more hazardous outside of the machine's falling object protection (structure).

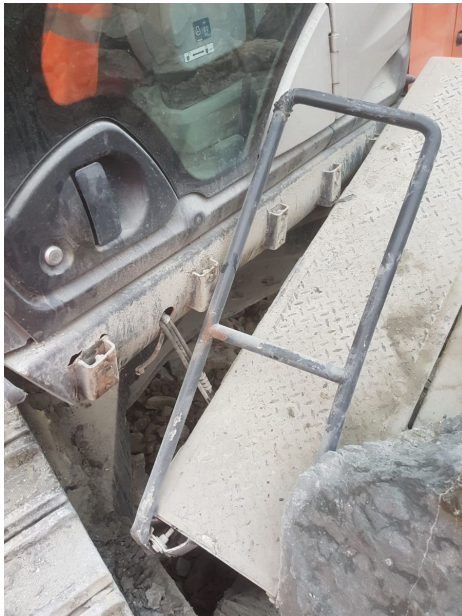
We wanted to identify a solution to the above, so that an operative can remove himself from a dangerous area without leaving the machine. Between ourselves and the excavator manufacturers, we have developed and installed an emergency bypass switch which enables us to do just this.
