BEST PRACTICE

LOCATION:	Asphalt/Coating plant	ARTICLE YEAR	2024
ACTIVITY:	Transport & Logistics / Delivery	COMPANY:	Northstone Materials Ltd
SUB ACTIVITY:	Delivering Asphalt & Hot Boxes	COMPANY LOCATION:	Northern Ireland
BEST PRACTICE No:	BP2221	COMPANY TEL:	0000
COUNTRY OF ORIGIN:

Device designed to hold open the chutes on the rear door of asphalt tipper lorries. - Topic 6

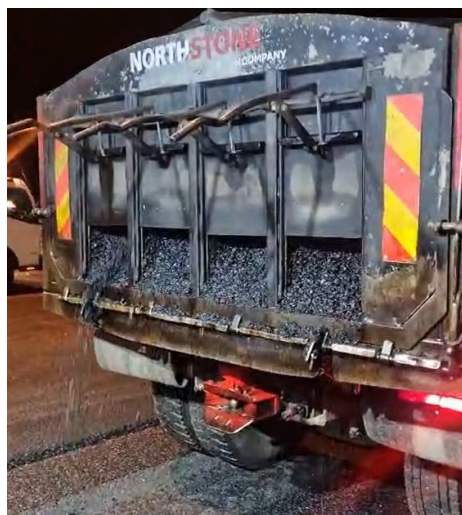
The images below show the device and the device being used.

The tail door on this style of tipper lorry is inset to the body rather than sitting external to it, so to close the tail door the contact surfaces need to be cleared. The driver has to either manually hold open or else insert a prop into the heavy tail door in order clear the door sill of hot material.

Please view the video to see the simple solution that was used to mitigate this hazard.
