INCIDENT ALERT

LOCATION: CEMENT PLANT
ACTIVITY: MAINTENANCE & HOUSEKEEPING
SUB ACTIVITY: N/A

ALERT STATUS: Normal
DATE ISSUED: 27/11/2012
INCIDENT No: 00346

Contractor Finger Injury

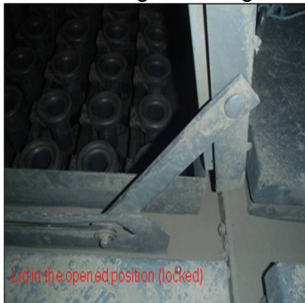
The lids have a sliding locking mechanism which prevents them from closing once this mechanism has locked into the lower runner position. The most likely cause of the incident is that the locking mechanism had not fully engaged, allowing the lid to drop on to the IP, when it was inadvertently knocked. As a result of the incident the contractor lost the ends of the two fingers down to the first knuckle.

Lid in Locked Open Position

- Upon investigation it was found that several of the lid locking mechanisms in the filter bank did not engage smoothly by gravity, needing additional force to be directly applied.

- The manufacturer's operations manual did not identify any maintenance regime for the lids. Do we check manufacturer manuals and incorporate maintenance regimes into our own, devising additional procedures where necessary?
