BEST PRACTICE

LOCATION:	Quarry	ARTICLE YEAR:	2012
ACTIVITY:	Maintenance & Housekeeping	COMPANY:	Breedon Aggregates
SUB ACTIVITY:	N/A	COMPANY LOCATION:	Cloud Hill Quarry
BEST PRACTICE No:	BP809	COMPANY TEL:	01332 694010
COUNTRY OF ORIGIN:	United Kingdom

Safe access and egress to binder screen

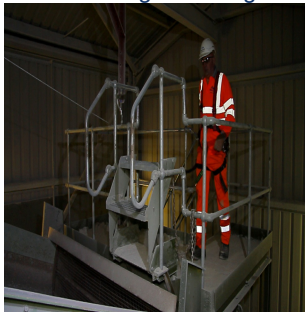
Quarry fitters at Breedon Aggregate's Cloud Hill Quarry raised the issue of very poor access to the quarry's main primary binder screen. They were required to access and maintain the top deck finger bars at least once per week with no real means of access. Ladders were used to gain access but as they were carrying tools, they were unable to maintain three points of contact.

The fitters and site management came up with the idea of creating a stairway and retractable steps to gain access and, in addition, installed a moveable/lockable gate mechanism to prevent falls from the end of the screen into the discharge chute.
