## BEST PRACTICE

LOCATION: Mobile Plant      ARTICLE YEAR: 2013  
ACTIVITY: Maintenance & Housekeeping      COMPANY: UK Coal Surface Mining Ltd  
SUB ACTIVITY: N/A      COMPANY LOCATION: Park Wall North Surface Mine  
BEST PRACTICE No: BP866      COMPANY TEL: 07740934641  
COUNTRY OF ORIGIN: United Kingdom

**Probe to safely remove stones stuck between dump truck tyres**

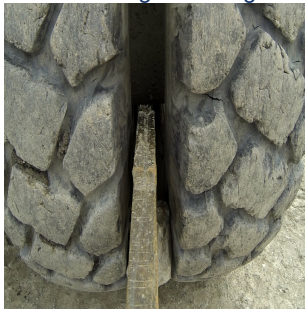
An engineering solution was designed and fabricated consisting of a large steel arm attached to the rear wall of an excavator bucket by means of a 'quick hitch coupler'. To remove wedged rocks, the dump truck operator contacts the excavator operator by radio and between them they position the truck so that the excavator can attach the probe and remove the rock.
