Lessons from Pennyvenie

Fatal Accident Focus

MPA Midlands - 'Safer by Sharing'
Lichfield - 9 February 2012

Martin Isles Director, Health & Safety, MPA

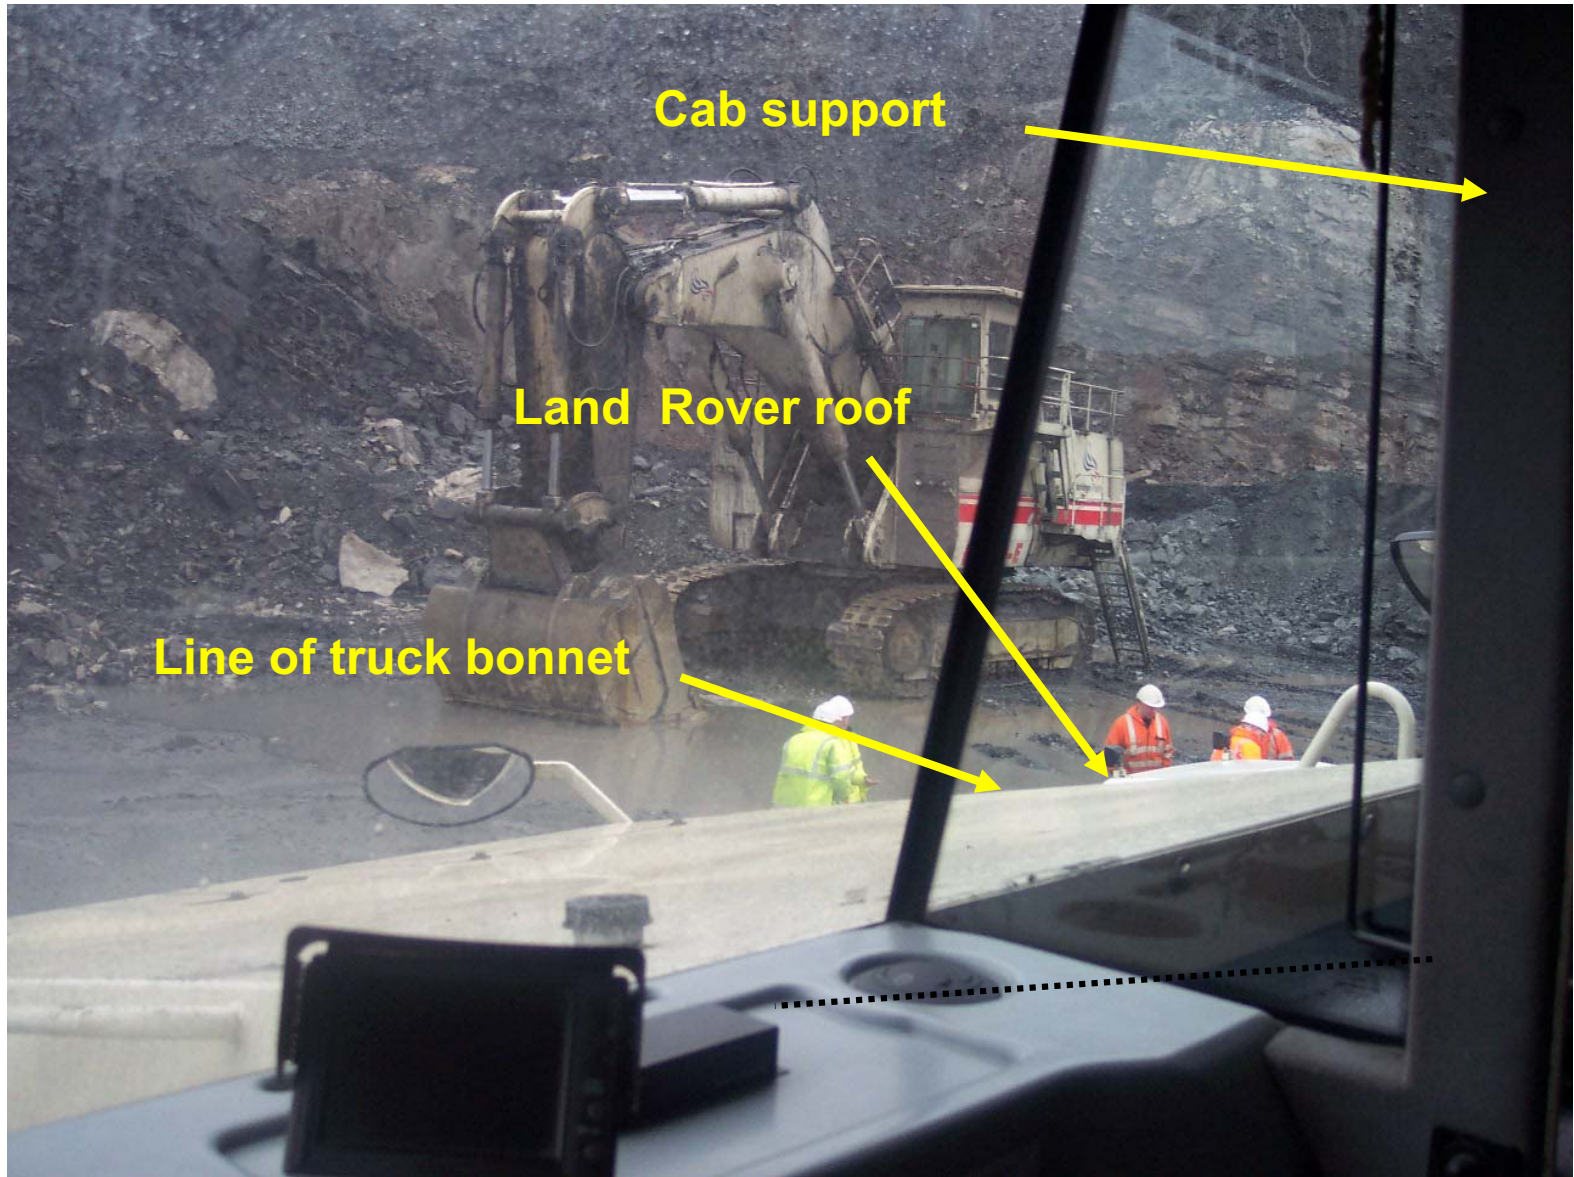
Cab support

Land Rover roof

Line of truck bonnet

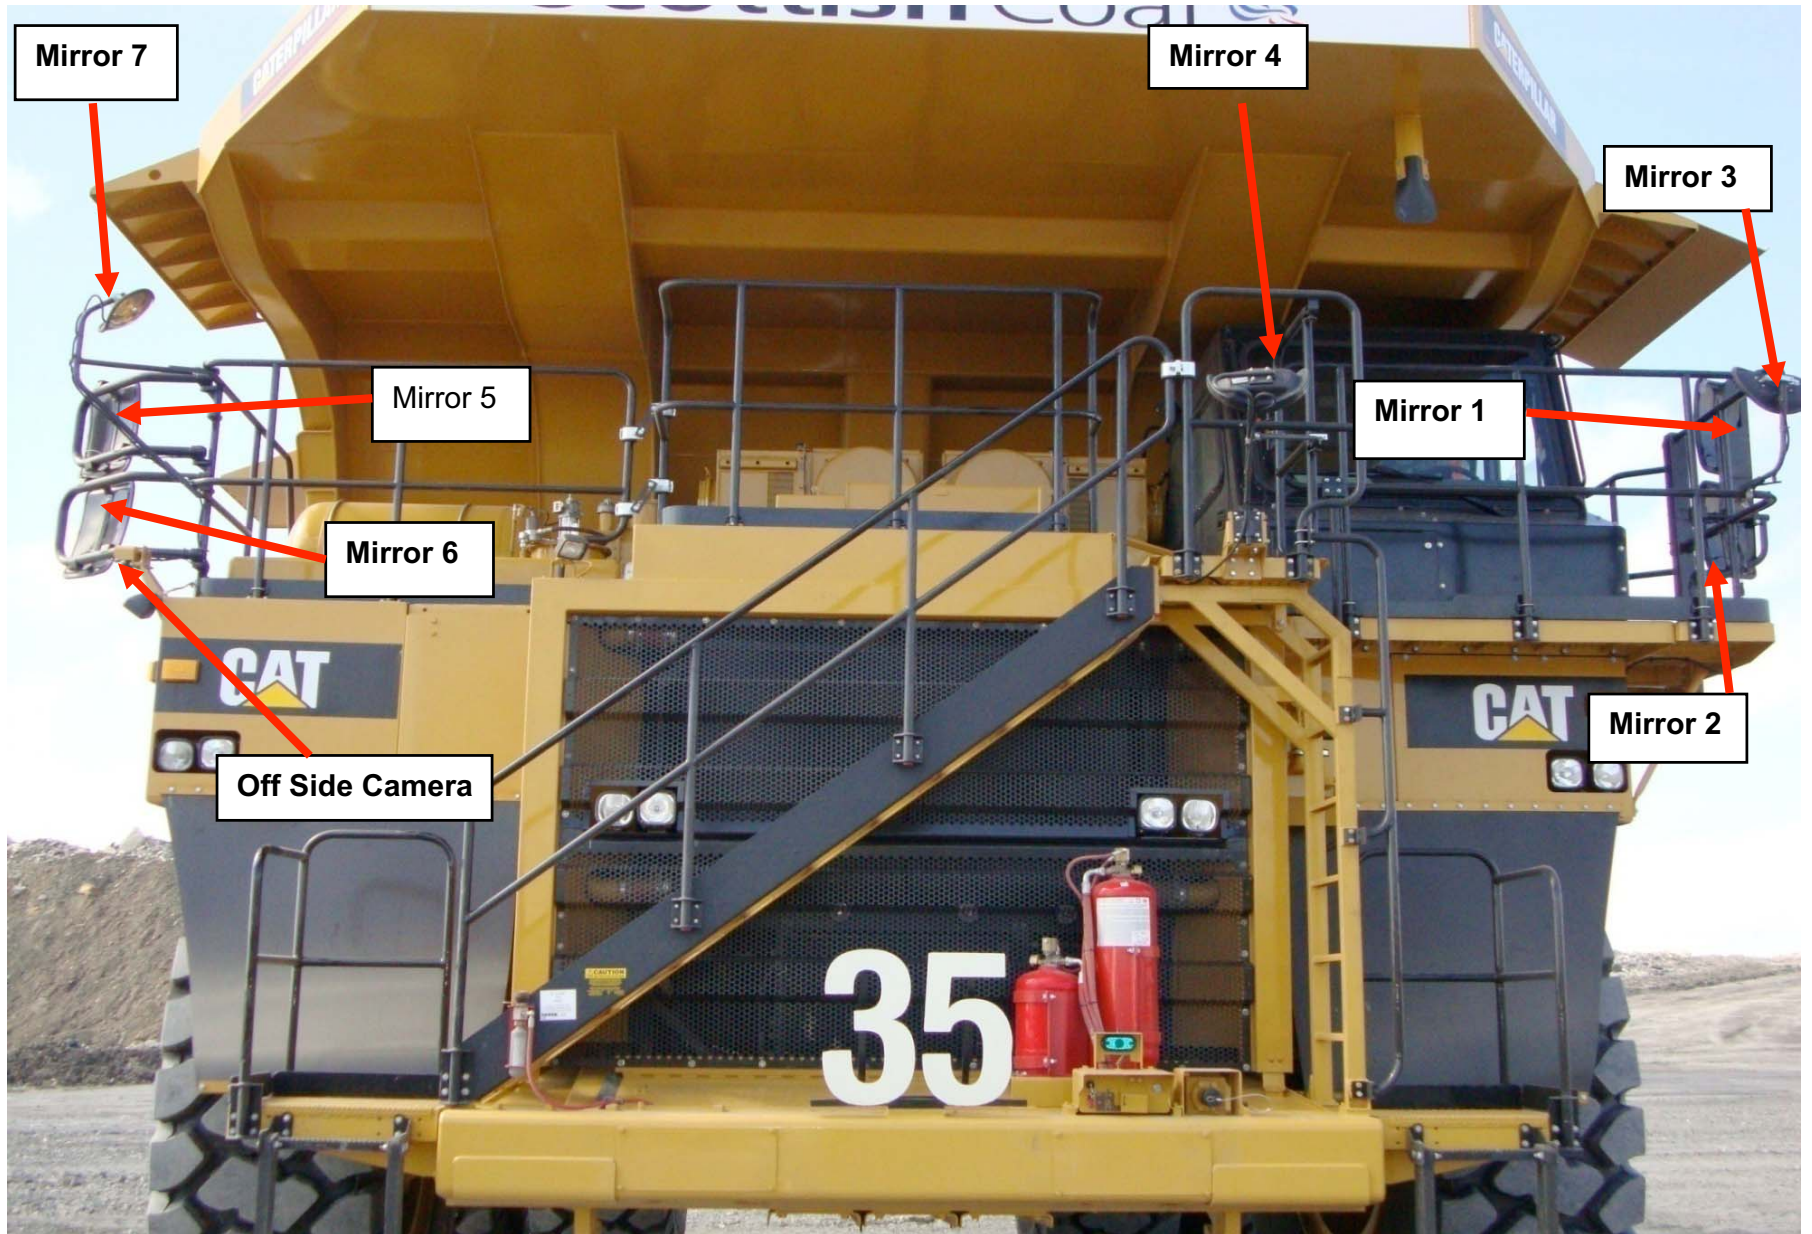
Mirror 7

Mirror 4

Mirror 3

Mirror 5

Mirror 1

Mirror 6

Mirror 2

Off Side Camera

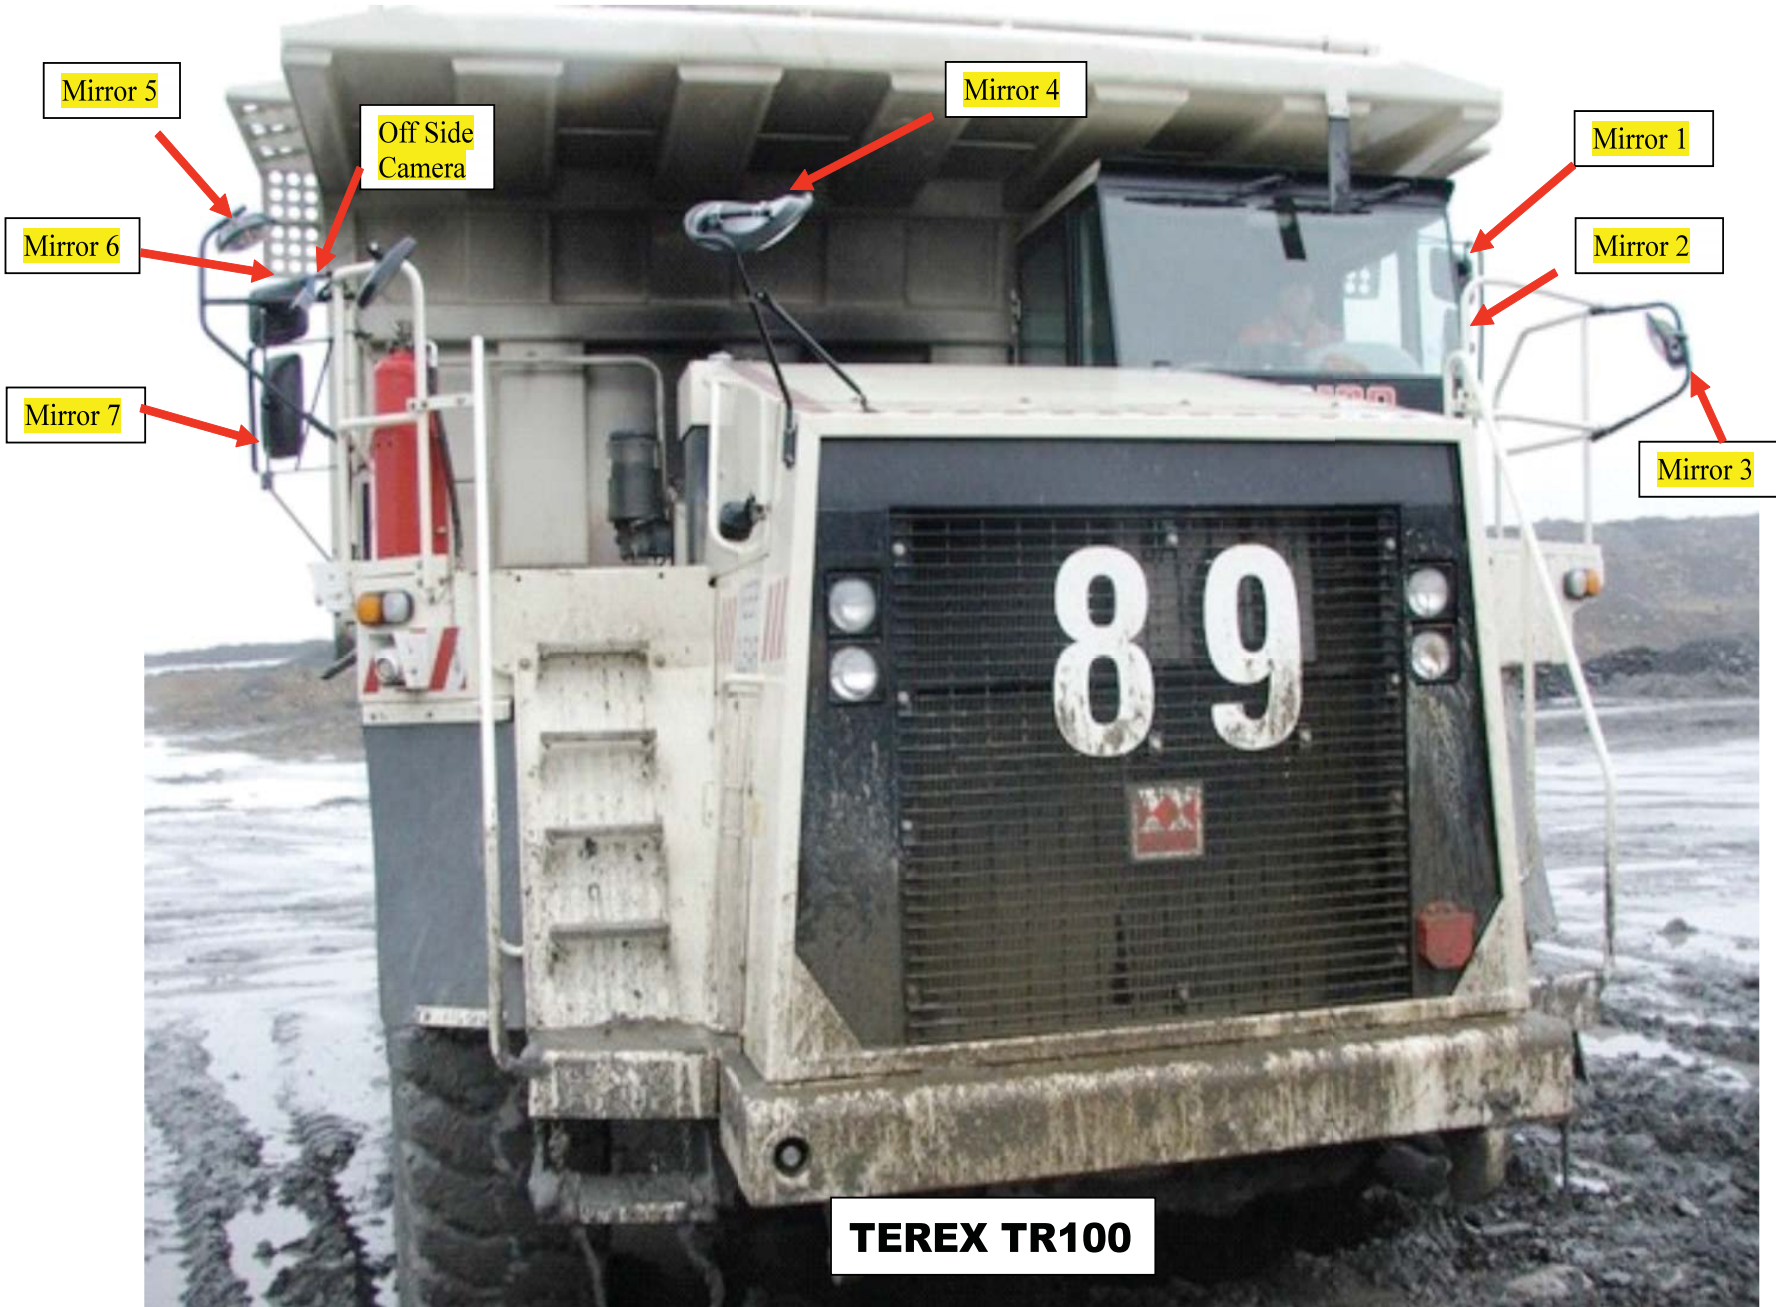
TEREX TR100

Mirror 5

Off Side
Camera

Mirror 4

Mirror 1

Mirror 6

Mirror 2

Mirror 7

Mirror 3

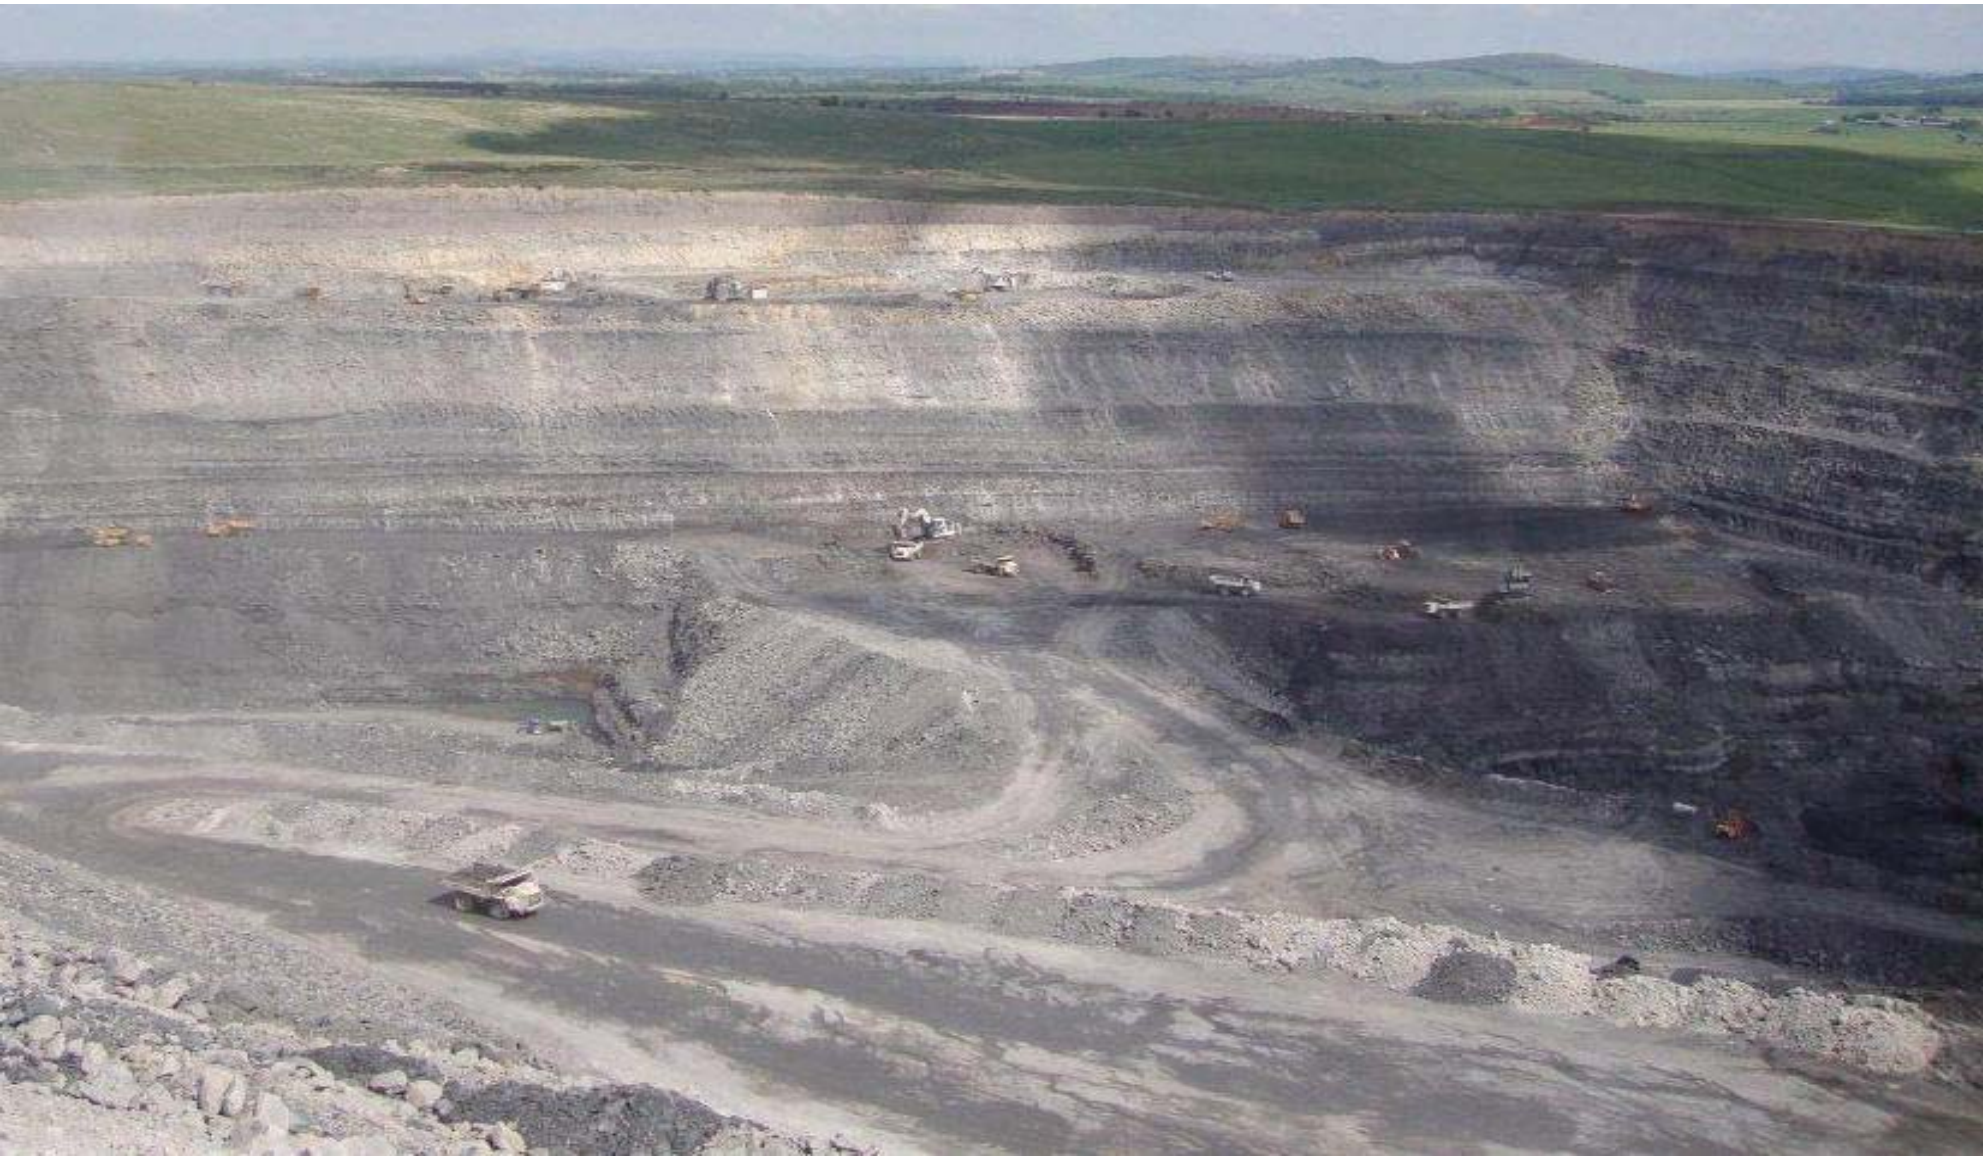
Supervisors Vantage Point + Radio protocol

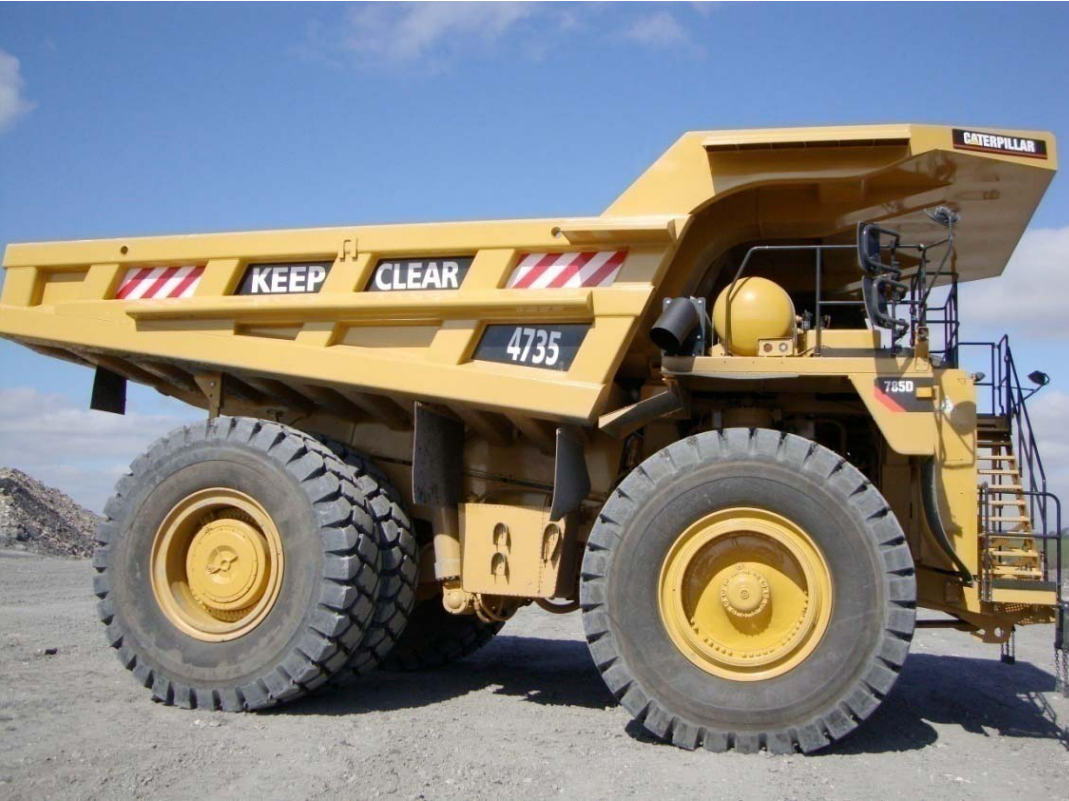
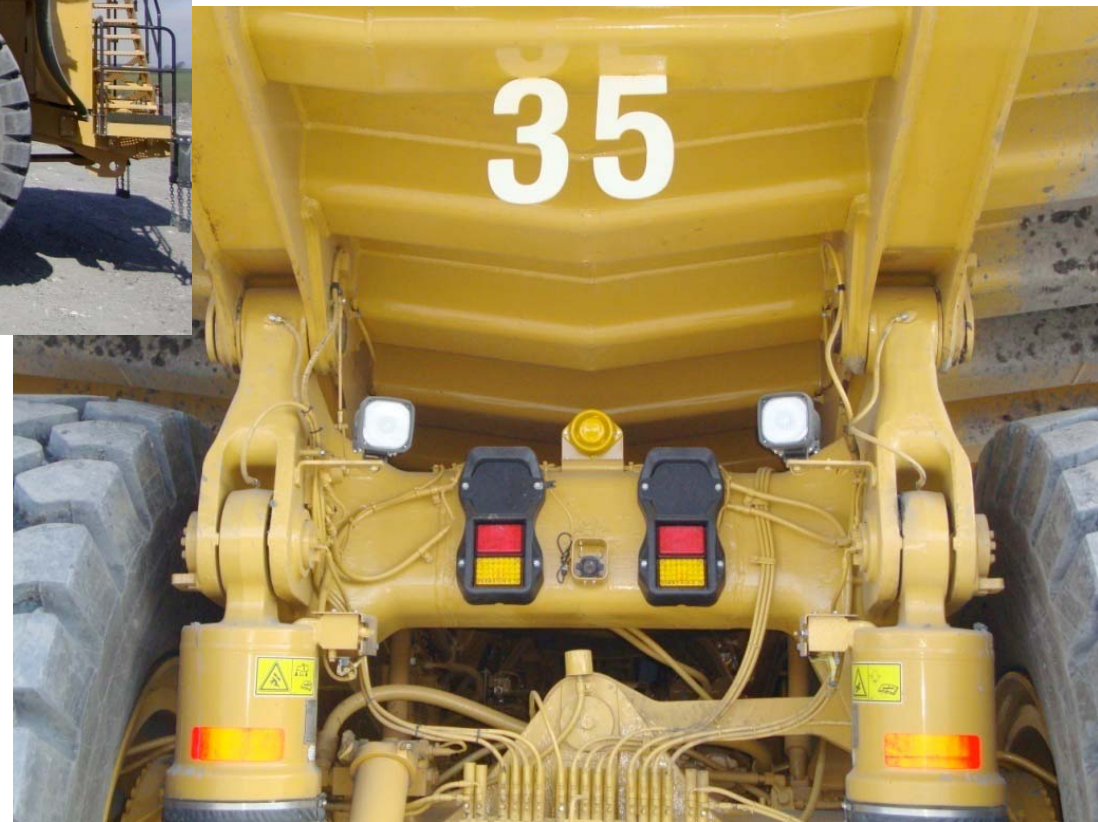
Vehicle Markings

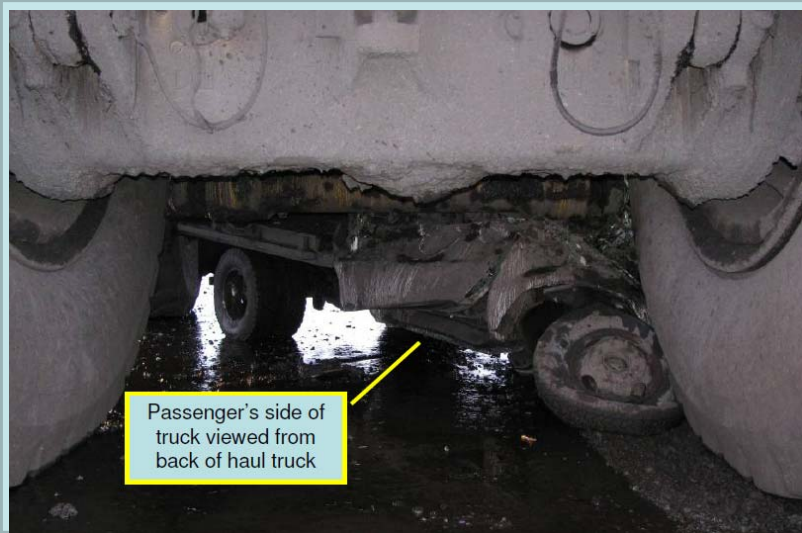
1 tonne
pick-up

Passenger's side of
truck viewed from
back of haul truck

USA 2010 - **Fatality**

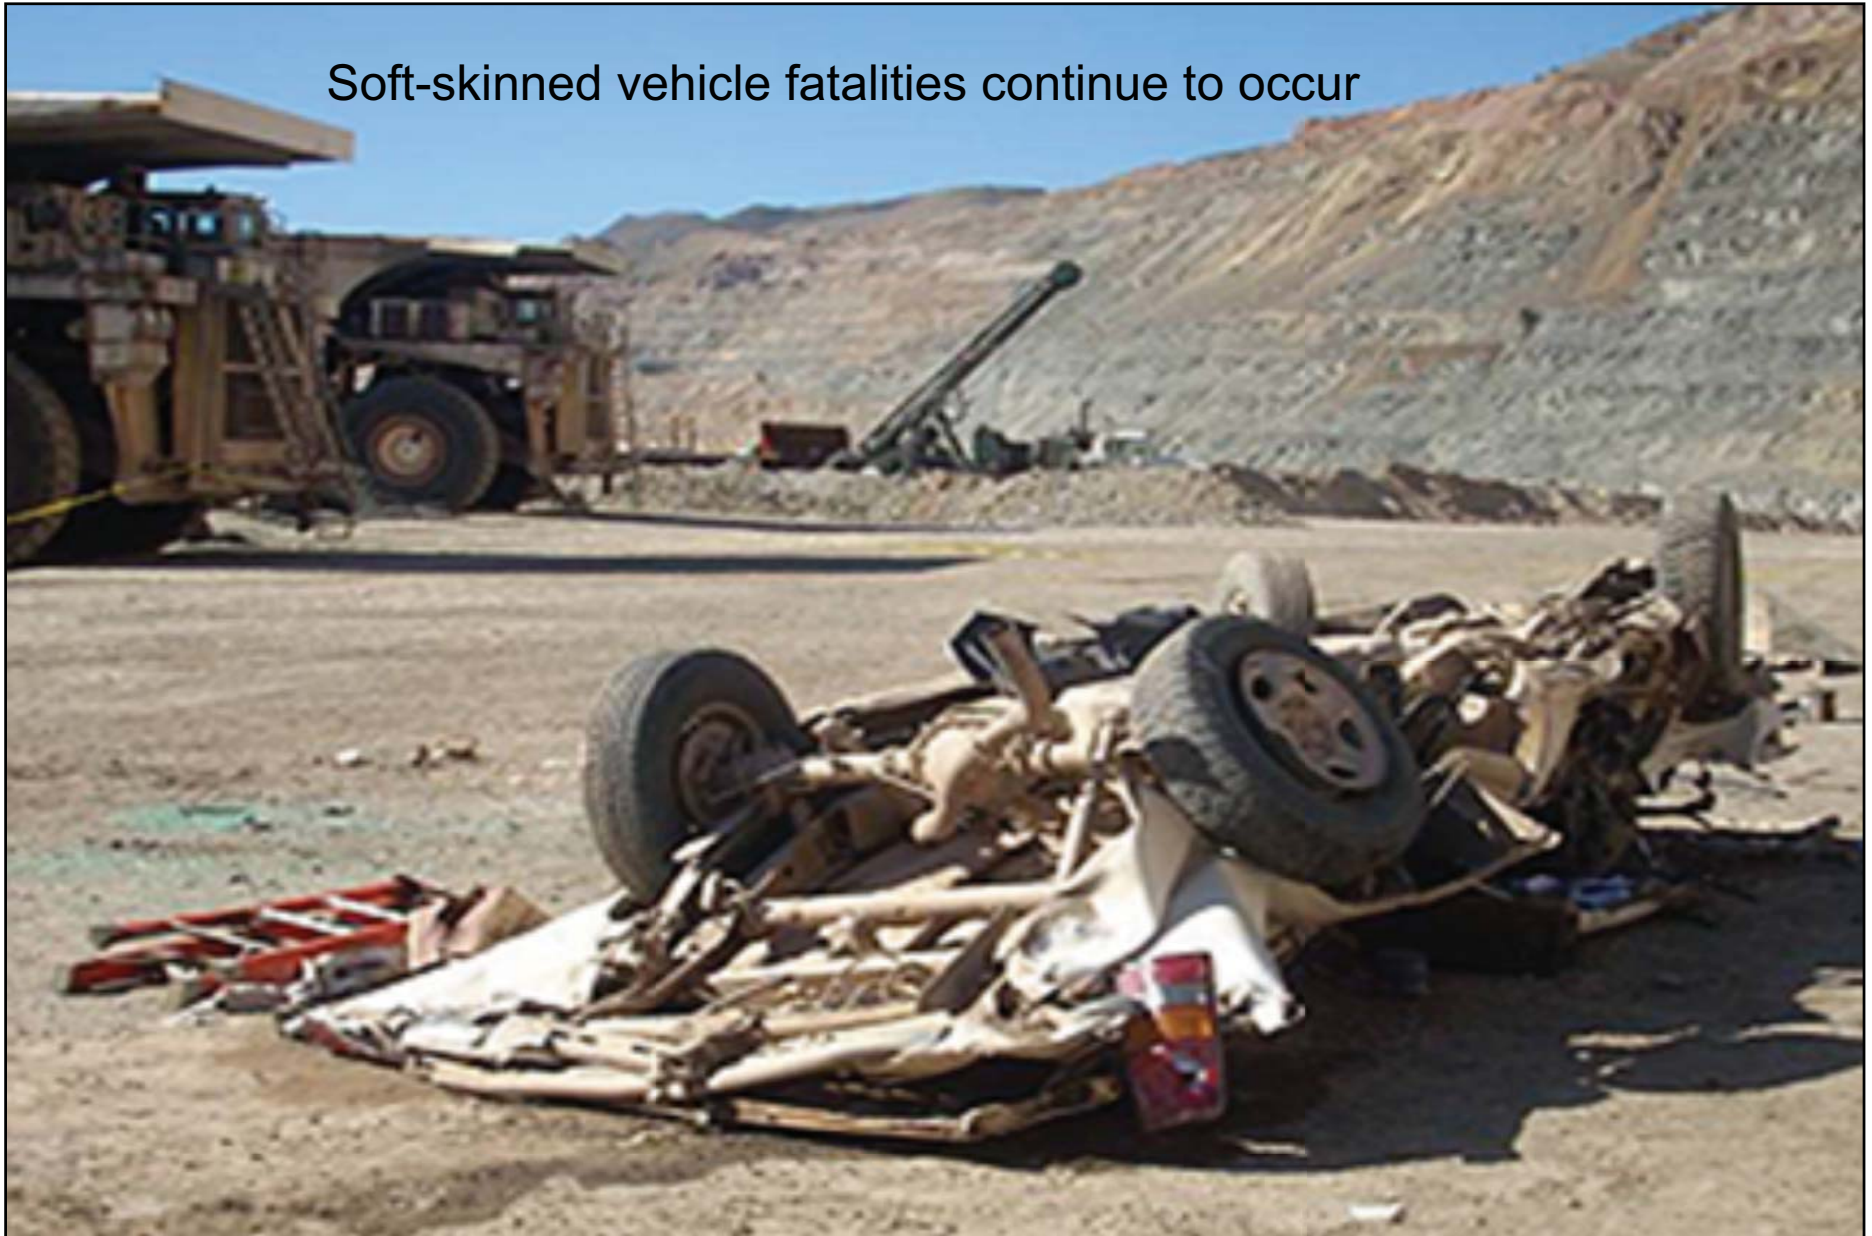
South Africa 2011 - Fatality

Toyota Hilux with roll-cage and inadequate buggy-whip

NB: Huge restriction to driver's offside vision
