## Industry Safety Alert

### **FATALITY - Excavation Collapse**

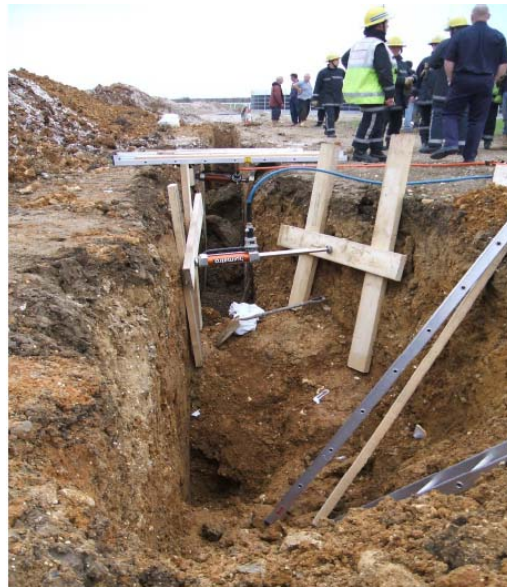
This incident and the one in the photograph, which almost resulted in the suffocation of a building worker when a three-metre trench collapsed on top of him, are stern reminders that we should not become complacent to the dangers of working in excavations and that a safe system of work must be in place before workers enter excavations.

- BE MINDFUL that relatively shallow excavations can also carry the potential risk of suffocation and crushing.
- ALL excavations, regardless of depth, should be assessed by a competent person for the risk of collapse and need for trench support. If there is any doubt, seek advice from your line manager.
- Pay particular ATTENTION to ground stability, changes in ground conditions, adequacy of support and undue loading to the trench edges.
- Make sure there is an adequate means of ACCESS/EGRESS
- ALWAYS check trench support/alternative safe system of work on a daily basis before work begins
- As work continues KEEP ASSESSING the working environment – have the influencing factors changed?
