# Bitumen Spill

LOCATION:	ASPHALT/COATING PLANT	ALERT STATUS:	Normal
ACTIVITY:	PRODUCTION AND PROCESSING	DATE ISSUED:	08/05/2007
SUB ACTIVITY:	AGGREGATE PROCESSING	INCIDENT No:	00127

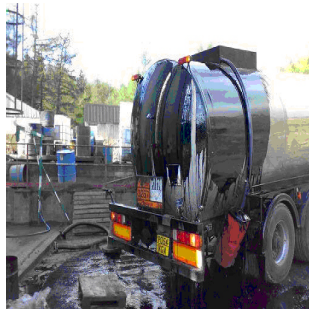
A bitumen delivery lorry ejected part of its load through an inspection hatch when swings bolts on the tanker became slack. The tanker, when pressurised ready for discharge, allowed pressurised bitumen to escape through the inspection hatch at the rear of the tanker spraying very high temperature bitumen into the surrounding area.

Aftermath of Bitumen Spill
