# Mixer Truck Nip Point

**ALERT STATUS:** Normal  
**DATE ISSUED:** 05/03/2015 12:13:19  
**INCIDENT No:** 00407

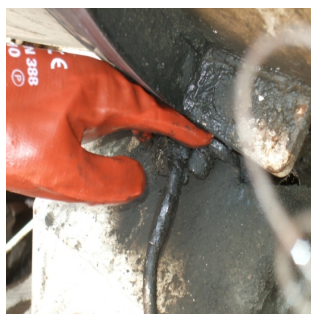
Nip Point

In a recent incident a truck mixer driver, working for an Independent Haulage Contractor, was lucky to escape more serious injury when he decided to grease the moving track ring of his drum with his gloved hand. His finger was trapped by the drum locking mechanism, resulting in the loss of his finger tip.

- The truckmixer was originally fitted with a remote greasing facility, incorporating a tangential plate and grease hose, allowing the track ring to be greased from ground level, away from the risk of entanglement; however the plate had been damaged and removed and the hose tucked out of the way. Is plant and equipment formally inspected? Are defects reported and repairs carried out promptly? Where necessary are interim precautions implemented to prevent injury?

- There was no written Safe System of Work for the activity and the truckmixer drum was moving at the time. Are documented Safe Systems in place for maintenance activities? Do they include the need to isolate all live / moving plant and equipment before undertaking any maintenance?
