Cutting Disc Failure

ALERT STATUS: Normal
DATE ISSUED: 15/03/2016 15:33:06
INCIDENT No: 01426

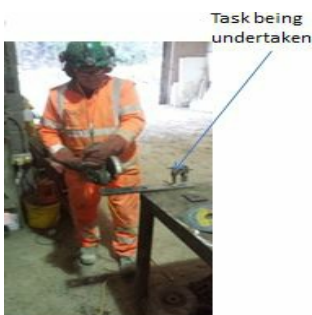
An employee was very fortunate not to have been more seriously injured whilst cutting some steel, when a 230mm cutting disc being used in a hand held grinder broke away from its centre hub. The disc struck the employee's cheek at high speed, causing cuts and grazes to his face.

The disc was not purchased by the site, it had been obtained via a contractor. It was only 1.9mm thick and had exceeded the manufacturers warranty expiry date. The employee was wearing safety goggles, but not a full face visor. He had received training in the use of abrasive wheels and the work piece was securely clamped

- Arrange for the steel to be pre-cut off site
- Use an alternative / better method of cutting
- Ensure discs are in good order, know how they have been used / stored and their expiration date
- Check discs thoroughly for defects before use
- Ensure the rpm rating of the disc is not exceeded
- Avoid the use of 1.9mm thickness discs
- Use cutting discs with great care; the force applied should be minimal and from directly above the cut being made
- Wear a full face visor and goggles

- Ensure Safe Systems of Work are in place for the use of hand held grinders
- Limit their use to authorised / competent personnel
- Purchase the right discs for the task and store them correctly
- Use the necessary PPE for the task, in this case goggles and a visor
