Cutting Disc Failure

ALERT STATUS: Normal
DATE ISSUED: 15/03/2016 15:33:06
INCIDENT No: 01426

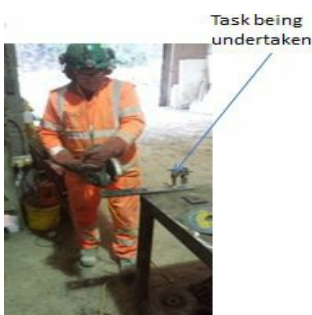
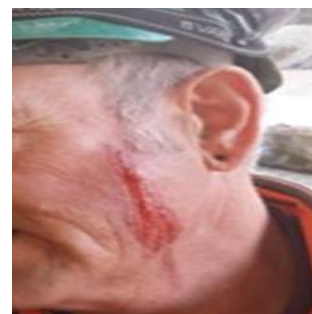
An employee was very fortunate not to have been more seriously injured whilst cutting some steel, when a 230mm cutting disc being used in a hand held grinder broke away from its centre hub. The disc struck the employee's cheek at high speed, causing cuts and grazes to his face.

The disc was not purchased by the site, it had been obtained via a contractor. It was only 1.9mm thick and had exceeded the manufacturers warranty expiry date. The employee was wearing safety goggles, but not a full face visor. He had received training in the use of abrasive wheels and the work piece was securely clamped

- Arrange for the steel to be pre-cut off site
- Use an alternative / better method of cutting
- Ensure discs are in good order, know how they have been used / stored and their expiration date
- Check discs thoroughly for defects before use
- Ensure the rpm rating of the disc is not exceeded
- Avoid the use of 1.9mm thickness discs
- Use cutting discs with great care; the force applied should be minimal and from directly above the cut being made
- Wear a full face visor and goggles

- Ensure Safe Systems of Work are in place for the use of hand held grinders
- Limit their use to authorised / competent personnel
- Purchase the right discs for the task and store them correctly
- Use the necessary PPE for the task, in this case goggles and a visor
