Collapse of standing trailer

LOCATION: CONCRETE PRODUCTS PLANT
ACTIVITY: TRANSPORT & LOGISTICS / DELIVERY
SUB ACTIVITY: LOADING

ALERT STATUS: Normal
DATE ISSUED: 21/04/2016 13:11:38
INCIDENT No: 01427

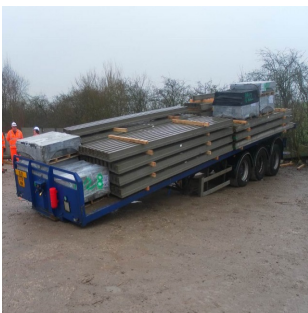
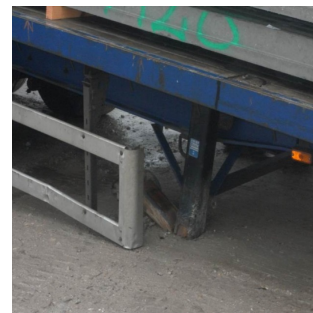
A contractor had just completed the loading of a pre-stressed beam and block consignment onto a 40ft third party haulier's standing trailer when the supporting legs gave way resulting in the partial collapse.

On this occasion the load remained intact and therefore the impact was damage only, but the potential was far greater.

Investigations identified that the weight of the load was appropriate for the trailer. However, the sequence of loading had placed excessive force onto the standing legs for a prolonged period of time, without a counter force / weight being applied to the axle area of the trailer bed. This caused the standing legs to fail.

- Review task risk assessments, ensuring all circumstances that could result in a vehicle / trailer collapse are identified and that appropriate control measures are implemented to prevent such an event
- Ensure all personnel responsible for loading are aware of the requirements of appropriate load distribution
- Ensure all loading and standing areas are appropriate (good, firm and level ground)
- Avoid leaving loaded trailers standing for prolonged periods of time
- Ensure vehicles and trailers are subjected to frequent and appropriate inspection by competent persons
- Formulate task specific SWP ensuring all loading operators are briefed/trained via toolbox talks accordingly and understand the safe systems of work. Maintain appropriate records
