Equipment mounted at height

ALERT STATUS: Normal
DATE ISSUED: 21/04/2016 13:23:27
INCIDENT No: 01428

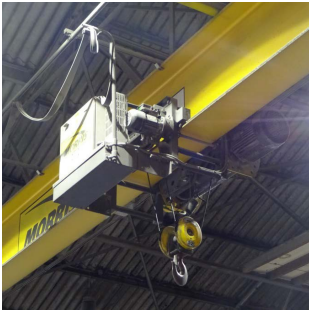
This alert is issued following a previous alert regarding the failure of a drive motor and gearbox mounted at height.

- Ensure Planned Preventive Maintenance (PPM) is scheduled in line with manufacturer's recommendations as a minimum
- In harsher environments and high usage, more frequent inspection may be required.

- Ensure all materials used in the PPM or breakdown repairs meet with the manufacturer's specification, and any other technical standards that may apply.

- Where individual component parts require replacing consider the benefit of replacing the whole assembly to avoid the potential for backlash.
- Carry out assessments identifying areas where equipment is mounted / travels over people, consider fitting a secondary securing device.

- Secondary securing devices prevent a component falling from height if the primary securing method fails. This could be a safety wire or some other engineered method designed for this function. Secondary securing devices should be sufficient to withstand the shock loading that may occur if the primary securing method fails.
