Buried Cable Strike

WHAT HAPPENED

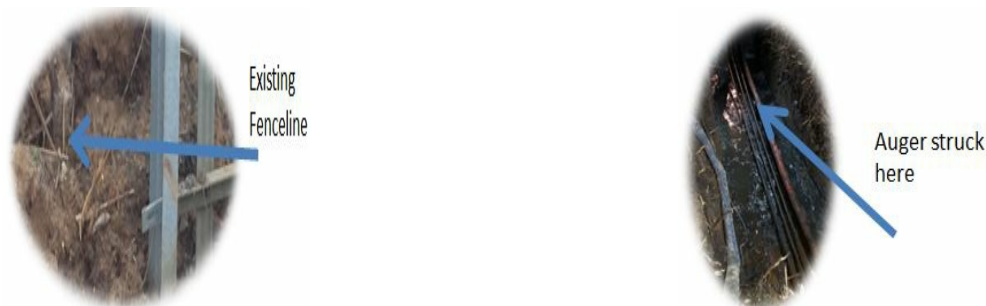
A contractor struck an 11kva cable with a mechanical auger whilst digging holes for fence posts around one of our sites. A pre-task meeting had been held and the positions of the holes and a low voltage cable on the site marked on the ground after scanning; unfortunately the contractor decided it would be easier to dig the holes further back from the agreed route, which took them into a neighbouring property and in close proximity to the high voltage cable.

A method of work had been agreed and Permit to Work and Worksafe completed. - Unknown to the site staff, the contractor decided it would be easier to dig the holes further back from the original fence line, to avoid an existing tree root, which took them into a neighbouring property.

The area they dug into had not been scanned because they were not supposed to be digging there

The contractors should have followed the instruction in the Permit to Work and method statement, digging in the prescribed locations.

Scanning of the adjacent land and access to the site plans of the neighbouring property may have increased awareness of the dangers of not following the agreed procedure.

- Ensure contractors understand that deviation from agreed Permits and methods of work is forbidden without prior approval from an authorised company Supervisor.
- Provide sufficient Supervision of contractors during these sort of tasks.
- Prior to excavating on site boundaries, consult neighbours in respect of buried service plans and scan for cables as appropriate.
