# Operatives hand injured during planing operation

## WHAT HAPPENED

**INCIDENT No:**

**01471**

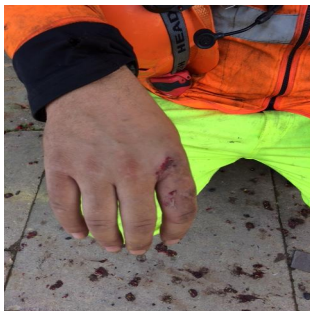
An operative was carrying out his duties on-site as a planer banksman. Whilst the asphalt planings were being conveyed into a lorry, a piece of breakout asphalt (weighing approximately 2.4kg) bounced off the side of the lorry and struck the operative. He suffered a small cut to his right-hand index finger just above the knuckle. Immediately after the incident, the following actions were taken.

**Injured hand**

1. Full investigation to be conducted by the Surfacing Divisions (assisted by the SHEQ Department) with all relevant documentation provided to Central Services.
2. Workforce to be informed to keep danger zones free and clear of persons, maintaining visibility at all times and to heighten awareness.
3. Review of possible safety protection systems to control hazard e.g. falling debris

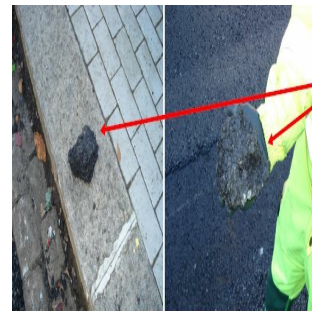
**Asphalt lump**

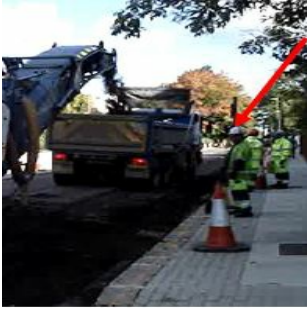
The image illustrates the position of the operative relative to the lorry and conveyor when he was struck by the asphalt.

**Operative position**
