Fall from height into water - BMAPA Alert

LOCATION: MARINE & SHIP TO SHORE
ACTIVITY: MAINTENANCE & HOUSEKEEPING
SUB ACTIVITY: N/A

ALERT STATUS: Normal
DATE ISSUED: 19/12/2017 18:30:26
INCIDENT No: 01478

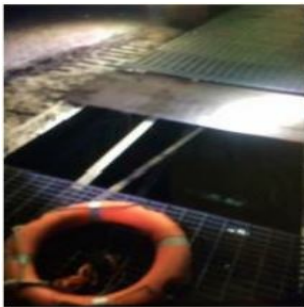
Upon leaving the crane, the deck hand stood on a section of walkway grid on the quayside that had worked loose due to vibrations from the crane. The grid had moved forward and was unsupported on its rear edge so when the IP stood on the unsupported side of the walkway, it pivoted on the central supporting beam resulting in both the individual and the grid falling into the river.

Missing grate

The IP stands on unsecure metal walkway grating that pivots, resulting in the person and grate falling into the water.

- Lack of inspection and maintenance of walkway gratings
- Gratings overlapping with the path of the tracked excavator
- Absence of physically marked exclusion zone
- Control of sub contractors (ships crew).

- Enforce prohibitive area by including in new pre-discharge procedure and establishing physical demarcation.
- Only named, authorised personnel to be permitted in the prohibited area
- Fix walk way grids so they can't vibrate loose
- Record inspections of walkways as part of pre-discharge procedure
- All personnel to wear life jackets
- Improved rescue equipment and man in water training for all staff.

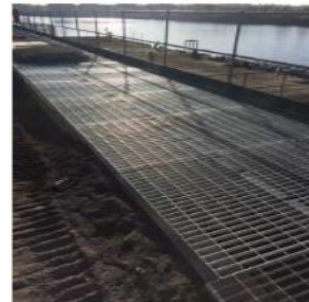
Grating secured - note overlap
