Failure of wire after stressing

CONCRETE PRODUCTS PLANT
GUARDING AND ISOLATION
NO SUB ACTIVITY AVAILABLE

ALERT STATUS: Normal
DATE ISSUED: 03/08/2018 17:04:20
INCIDENT No: 01493

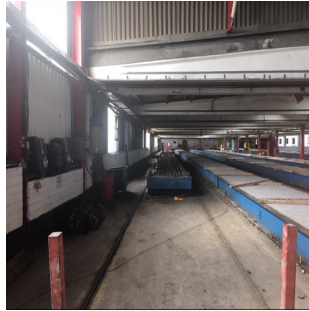
During a routine stressing procedure using 5 mm wire for the production of wet cast T-beams, a wire snapped in the centre of the bed seconds after the bed had been stressed and the pins inserted, causing an unplanned release.

The two broken parts traversed to either end of the bed travelling underneath the restraining chains, exited the end of the bed and continued to travel some distance down the workshop.

The wire was quarantined and both ends of the broken wire sent away for independent metallurgical examination. The conclusion was that the wire had been welded resulting in decarburisation.

Note: Clause 7.1.4 (Welds) in BS 5896:2012 High tensile steel wire and strand for the prestressing of concrete – Specification states that: "Wire shall contain no welds in the product as supplied by the manufacturer. Strands with normal production lengths may contain welds made in the individual wires before cold drawing, but shall not contain any welds made during or after cold drawing. Not more than one weld in any component wire shall be permitted in any 50m of strand."

- Not to rely totally on the restraining chains.
- An enhanced exclusion process with a time factor built-in during and immediately following the stressing process, has been implemented.
- Additional guarding at the live end and safe, guarded zones for the operative undertaking the stressing process have been introduced.
- Ensuring that the wire conforms to the British Standard.
