Stressed 12.5 mm. strand slipping - Use and maintenance of barrels and wedges

ALERT STATUS: Normal
DATE ISSUED: 10/01/2019 11:49:31
INCIDENT No: 01502

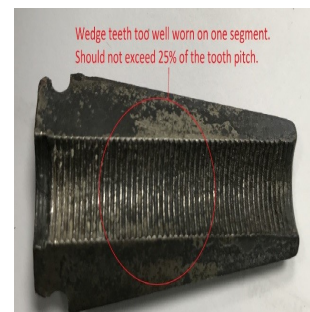
Figure 1

After sending the barrel and wedge which were involved in this incident for inspection, it was found that the teeth on the wedge had become flattened (see Figure 1).

- When inspecting the barrels and wedges it must be done in good light, with the aid of a magnifying glass.
- Wire brushes must be used to remove any dirt from the barrels and wedges when cleaning.
- All barrels and wedges must be thoroughly cleaned, examined and lubricated after each use.
- Ensure the site-specific safe system of work procedure for the cleaning of barrels and wedges is followed and the operative doing so is trained and competent in this procedure.
- Any barrels or wedges that are damaged or not fit for use **MUST** be discarded immediately.
- The daily inspection sheet which is completed after each inspection must contain the number of wedges inspected and the number discarded.
