# Fatal 6 - Return roller nip guard on conveyor falls 4m and hits contractor

**LOCATION:** QUARRY  
**ACTIVITY:** MAINTENANCE & HOUSEKEEPING  
**SUB ACTIVITY:** N/A

**ALERT STATUS:** Normal  
**DATE ISSUED:** 28/05/2019 12:02:48  
**INCIDENT No:** 01512

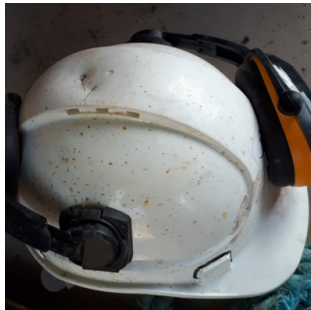
Hard hat with dent along back near centre

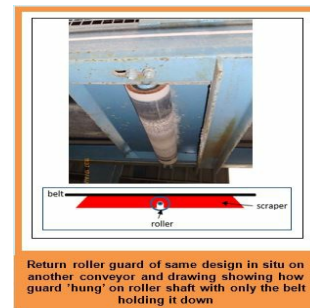
The contractor was standing under the incline conveyor belt system as he pulled the old conveyor belt through the system. During this operation an original return roller nip guard was dislodged. Investigation showed that it was designed so that it hung over the roller shaft and was only held in place by the belt and gravity.

The guard weighing circa 8kg fell 4m and hit the contractor on the centre of his hard hat. Fortunately, the contractor suffered only neck and muscle strain and was able to continue working after a short period.

- Check to see if this type of system is present on your site
- If they are on site, amend risk assessments / safe systems of work to include the need to check how roller nip guards, rollers and scrapers are secured
- Ensure all return roller nip guards, rollers and scrapers are securely fixed before any conveyor belt replacement work commences
- Any person carrying out a task where objects or items above them could fall should wear a hard hat, not a bump hat.
- Exclusion zones should be set up in any area where equipment is being worked on overhead
