Fatal 6 - Serious road traffic accident involving volumetric vehicle overturning

ALERT STATUS: Normal
DATE ISSUED: 24/07/2019 14:21:53
INCIDENT No: 01519

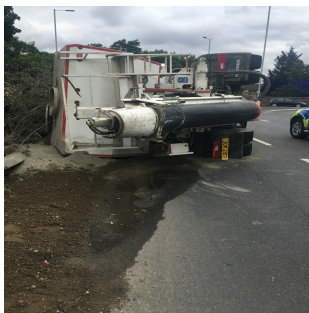
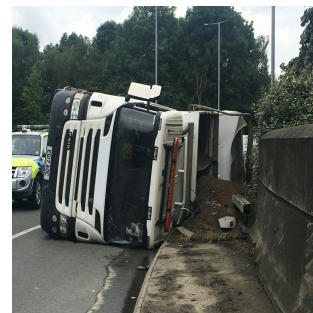
The driver slowed down as he approached a roundabout in the first lane, as he entered the roundabout, he accelerated to continue on the main road at the second exit. As the vehicle passed the 1st exit and continued to steer around the roundabout, the rear right wheels lifted. This action made the chassis flex and caused the metro flow tank at the rear of the vehicle to lean. This caused the load to shift which resulted in the vehicle toppling over. The vehicle fell onto the passenger side. No other vehicles were involved.

The driver was taken to hospital by ambulance, once assessed he was released with only bruising and a pain in his right leg. The lack of any major injuries was due to the driver wearing his seatbelt. The vehicle was recovered to the depot for assessment of damage.

- Provide an Incident Notification
- Lessons Learned document will be produced within 14 days
- Ensure loads on volumetric vehicles are evenly distributed
- Ensure that the gross weight is recorded before exiting sites
- Request and review all footage and documentation
- Investigation into incident by SHEQ Manager in conjunction with Transport Supervisor
 - Interview driver
 - Request information from Police (CAD number recorded at scene)

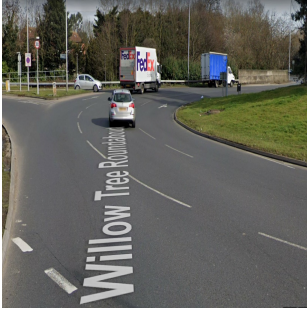
The image below shows the road where the accident occurred, the blue van marks the position where the vehicle overturned.

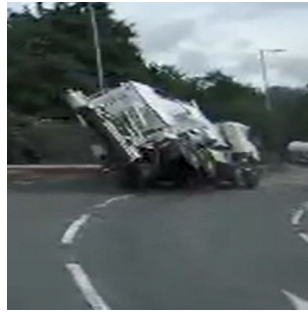
Camera image of vehicle overturning

A camera captured an image prior to the truck toppling over.
