Fatal 6 - Isolator safety device failure

Isolator could be turned on with castell system engaged

READYMIX OR MORTAR PLANT
MAINTENANCE & HOUSEKEEPING
N/A

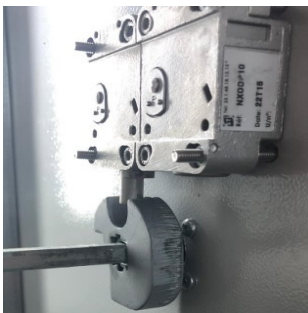
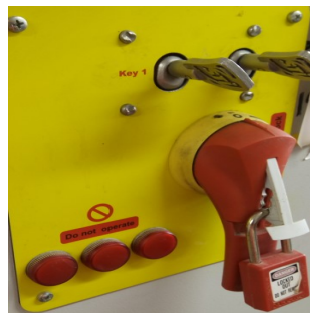
Please see images below of block with castell bolt located correctly in the top and isolator switch in off position with padlock attached.

- All similar systems should be checked by competent person to ensure blocks are in correct position, grub screws are tight and blocks cannot move on the shaft.
- Isolators should be locked off with padlocks even if connected to an interlocking system
- Always check the isolator cannot be turned on as part of the 'Try Out' section of the LOTOTO system
