Fatal 6 - Isolator safety device failure

Isolator could be turned on with castell system engaged

READYMIX OR MORTAR PLANT
MAINTENANCE & HOUSEKEEPING
N/A

ALERT STATUS: Normal
DATE ISSUED: 06/08/2019 17:28:36
INCIDENT No: 01520

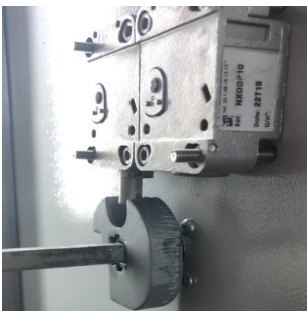
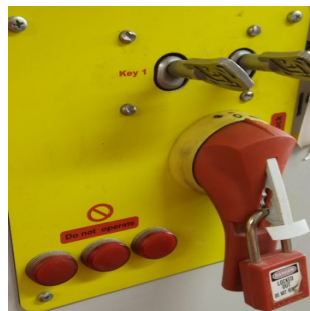
An examination revealed that the block the castell key bolt should have engaged with had worked loose and turned 90 degrees. This meant that the bolt was not engaged in the recess of the block, this enabled the isolator to be moved with the keys out. The isolator switch locates on end of shaft. Block should turn with shaft if grub screw is done up correctly. See image

Grub screw that worked loose causing the block to turn 90 degrees on shaft meaning the interlocking system bolt did not engage on block

Please see images below of block with castell bolt located correctly in the top and isolator switch in off position with padlock attached.

- All similar systems should be checked by competent person to ensure blocks are in correct position, grub screws are tight and blocks cannot move on the shaft.
- Isolators should be locked off with padlocks even if connected to an interlocking system
- Always check the isolator cannot be turned on as part of the 'Try Out' section of the LOTOTO system
