Fatal 6 - Isolator safety device failure

Isolator could be turned on with castell system engaged

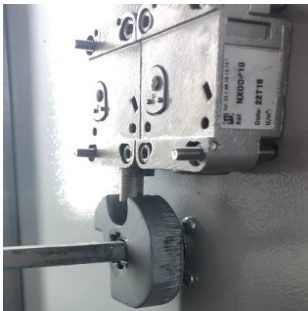
Please see images below of block with castell bolt located correctly in the top and isolator switch in off position with padlock attached.

- All similar systems should be checked by competent person to ensure blocks are in correct position, grub screws are tight and blocks cannot move on the shaft.
- Isolators should be locked off with padlocks even if connected to an interlocking system
- Always check the isolator cannot be turned on as part of the 'Try Out' section of the LOTOTO system
