Fatal 6 - Bitumen spill due to faulty butterfly valve

ASPHALT/COATING PLANT
MAINTENANCE & HOUSEKEEPING
N/A

ALERT STATUS: Normal
DATE ISSUED: 25/11/2019 10:06:02
INCIDENT No: 01536

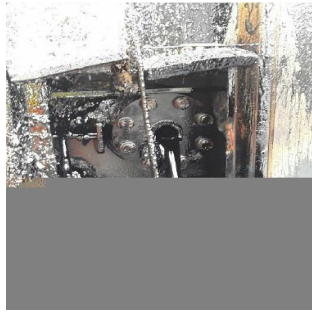
An external fitter was attempting to replace a pressure sensor probe which was situated at the bottom of a vertical bitumen tank. He removed the cover plate to gain access to the butterfly isolation valve, due to the valve handle being missing he used mole grips to turn the butterfly valve 90 degrees. He assumed because he had turned the valve until it stopped, that the valve was fully closed. This was not the case. He then loosened the damaged pressure sensor with a large adjustable spanner and started to remove it by hand. The sensor probe was easily removed but the bitumen started pouring out of behind the sensor and by then it was too late to put it back in as the butterfly valve was obviously open instead of shut. The fitter was wearing welder's gauntlets and a fireproof boiler suit but a small amount of bitumen trickled down the boiler suit into the gauntlet causing a burn covering the back of the left hand. The investigation highlighted that the butterfly valves are not suitable as there is no way of positively identifying what position the valve is in. The manufacturer is now fitting gate valves as standard instead of butterfly valves to prevent this issue.

Butterfly Valve with Sensor Probe removed

Gate valves utilise a movable gate or door to allow or prevent flow. In most cases the gate is raised or lowered using a mechanical assist of some kind – often a threaded screw. Flow is initiated by lifting the gate and prevented by lowering the gate. The following action is being taken: - All bitumen tanks to be investigated to determine which type of valve is fitted. - Butterfly valves are to be replaced with gate valves during the next pressure sensor change by a trained and competent person. - This work should only be carried out after the bitumen tank is either empty or completely cooled to reduce the risk of this incident happening again.

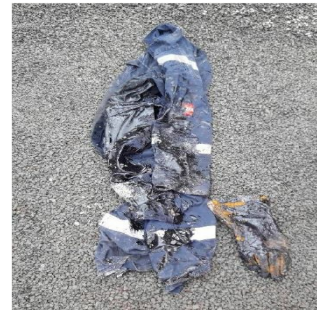
Bitumen covered PPE
