Hydraulic Tipper Door Injury

LOCATION: CONSTRUCTION/DELIVERY SITE
ACTIVITY: TRANSPORT & LOGISTICS / DELIVERY
SUB ACTIVITY: PRODUCT DELIVERY

ALERT STATUS: Normal
DATE ISSUED: 11/12/2019 09:30:37
INCIDENT No: 01539

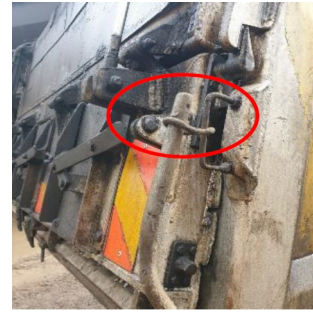
Due to the retaining rings which hold the doors closed not being released before the air ram button was pressed, this put pressure on the door release handles. When the driver came to release the handles by lifting the rings, the split door opened under pressure and hit him on the side of his upper body near his ribs, causing significant bruising.

Door Handle Retaining Ring

All drivers should be aware of their responsibilities when carrying out tipping operations.
