# Hydraulic Tipper Door Injury

**ALERT STATUS:** Normal  
**DATE ISSUED:** 11/12/2019 09:30:37  
**INCIDENT No:** 01539

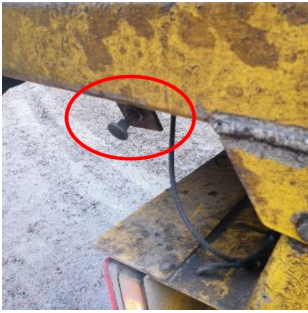
A tipper truck was reversing on site to tip and was being guided by the site banksman who was part of a contractors site staff. The banksman had stopped the truck, and whilst the driver was engaging the PTO for raising the body of the truck, the banksman took it upon himself to push the button to operate the air rams for the split half door.

**Air Ram Release Button**

Banksmen are NOT to touch any part of a vehicle or plant unless instructed to do so by the driver, or as part of their normal duties.

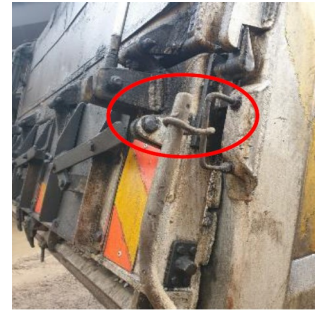
Due to the retaining rings which hold the doors closed not being released before the air ram button was pressed, this put pressure on the door release handles. When the driver came to release the handles by lifting the rings, the split door opened under pressure and hit him on the side of his upper body near his ribs, causing significant bruising.

**Door Handle Retaining Ring**

All drivers should be aware of their responsibilities when carrying out tipping operations.
