# 'The Fatal 6' - Struck by Moving/Falling Object - Falling Tool

<b>LOCATION:</b>	<b>CEMENT PLANT</b>	<b>ALERT STATUS:</b>	<b>Normal</b>
<b>ACTIVITY:</b>	<b>MAINTENANCE &amp; HOUSEKEEPING</b>	<b>DATE ISSUED:</b>	<b>11/02/2020 10:41:45</b>
<b>SUB ACTIVITY:</b>	<b>N/A</b>	<b>INCIDENT No:</b>	<b>01548</b>

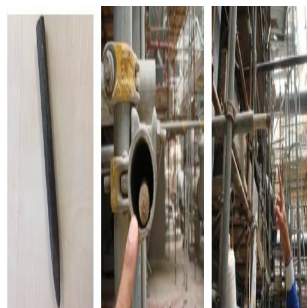
Tool & Location

During a dismantling of some fixed scaffolding by the onsite scaffolding contractor, a tool from a Jack hammer fell from the open end of scaffolding tube several meters to the ground below. It became apparent a third party contractor had previously placed the tool inside the horizontal scaffolding tube for storage.

The investigation is ongoing however it became apparent this is not a standalone incident and although this was raised several years ago with controls for elimination, the incident has occurred at least once previously. A full review of controls is being completed.

- Safety concern communicated to contractors.
- A TBT generated as a means of informing all future scaffolding activities.

Best practice is to cap all horizontal scaffolding tubes where known personnel may be working. The use of these end caps reduces the likelihood of items being placed into an open end tube.
