# Deneholes

**ALERT STATUS:** Normal  
**DATE ISSUED:** 23/03/2009  
**INCIDENT No:** 00219

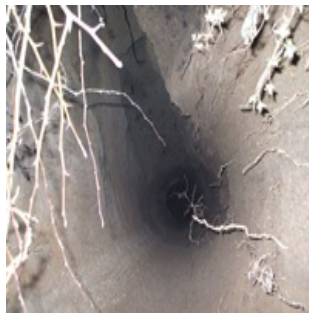
During a nightshift on the M25 widening works between junctions 1b – 3 in Jan this year, a ‘hole’ was observed in the verge approximately 1.75m from the edge of the northbound carriageway (MP 12/9). On closer inspection 2 engineers approximated that the ‘hole’ was over 1.5m diameter and in excess of 5m deep. Fortunately this was seen before anyone fell into it.

Following a CCTV survey and the attendance of a Geotechnical Engineer the hole was identified as a ‘Denehole’ and measured to a depth of 10m. Deneholes are manmade excavations carried out in the early 16th and 17th century to enable access to unpolluted buried chalk materials which were then spread on fields as fertiliser. They are particularly prevalent in the Kent and Essex area.

The small access shaft seen at ground level normally widens out to a cavernous network underground.

Unfortunately no mapping exists of the locations of these Deneholes and they are only accurately located once they become exposed. There is no visible scarring at ground level and no features identifying their locations.

- 1) Increased level of vigilance when working off carriageway, particularly in the South East.
- 2) Any suspect areas of ground should be probed for soft areas prior to walking on them or otherwise avoided.
