Fatal 6 - Near Miss – Rotary Saw Tooth Failure

ALERT STATUS: Normal
DATE ISSUED: 19/02/2020 11:52:10
INCIDENT No: 01549

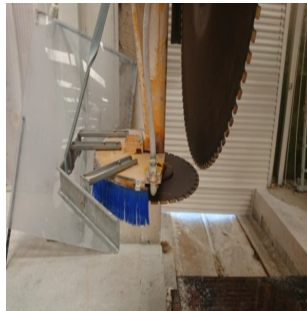
A tooth came off a small horizontal saw blade and hit the operator bruising his leg. He was standing about 4 metres from the machine at the time. Although this did not result in a lost time incident the outcome could have been a lot more serious.

Image with new guard fitted

- An adaption to the guard in stainless steel was manufactured and fitted – see image.
- This adaption is adjustable and, if a tooth should come off, it would hit the guard preventing the operator from being in the line of fire
- **Risk changers** – the company is looking at replacing the equipment with a fully enclosed machine, so the operator has no need to go into the sawing area when the blade is running.

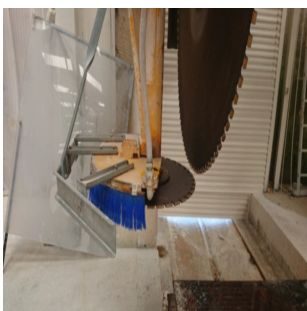
Image of new guard
