Fatal 6 - Working at height - BMAPA Alert

LOCATION: AGGREGATE DREDGER
ACTIVITY: ACCESS & EGRESS & WORKING AT HEIGHT
SUB ACTIVITY: N/A

ALERT STATUS: High Potential
DATE ISSUED: 04/03/2020 18:04:46
INCIDENT No: 02551

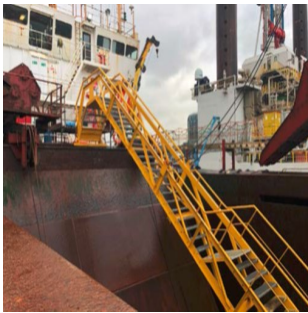
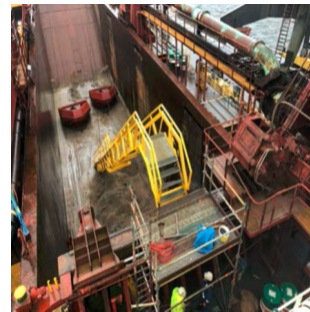
A UK marine aggregate dredger was undergoing a routine repair stop. A Permit to Work was raised to allow access to the cargo hold for repair yard employees, the cargo hold was cleared, and the gangway was slung for lifting out. The two employees exited the cargo hold via the gangway and immediately started to dismantle the handrails around the cargo hold access at the aft side of the scaffolding tower.

The Permit to Work did not cover the removing of the scaffolding, employees were not certified scaffolders and they were not wearing safety harnesses. As a result of the handrails being removed, they had exposed themselves to a 10m fall into the bottom of the cargo hold. The vessels Safety Officer intervened, stopped the job and removed the employees from the vessel.

Shows where scaffolding was removed

- Lack of risk awareness by repair yard employees with regard to Working at Height and of following clear safety procedures.
- The employees were not trained, authorised or competent to dismantle scaffolding
- The initial investigation report from the repair yard was unsatisfactory.
