Leading edge working and fall arrest

ALERT STATUS: Normal
DATE ISSUED: 07/04/2020 13:06:17
INCIDENT No: 02556

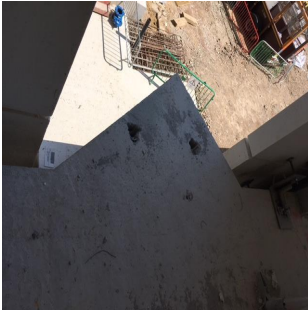
Internal view

An operator was working on a leading edge at Level 01 drilling remedial holes in the RC slab edge. The operative left the exclusion zone to retrieve dust suppression equipment. When he returned, he failed to clip back on to the anchor point before resuming work.

By failing to clip back on the operator exposed himself to the risk of a serious fall. The two images show the the area he was working on from the inside and outside.

- Toolbox talk provided to all operatives working on site in relation to working at height and the correct use of fall arrest equipment.
- 'STOP' campaign training provided to all operatives by principal contractor.
- Operatives to work in pairs 'buddy system' when working at height or carrying out high risk activities.
- Work at height permit system introduced.
