Concrete Supervisor Cement Burns

READYMIX OR MORTAR PLANT

00284

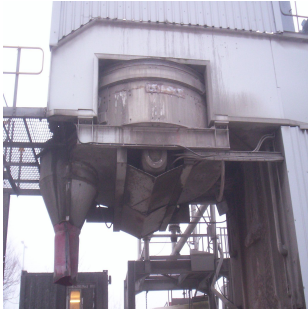
Whilst carrying out maintenance; a Plant Supervisor was cleaning out the concrete build up within a 3 metre pan mixer prior to fitting some new paddle arms and tips. The Supervisor was wearing a full set of waterproofs to enter the mixer.

Mixer Position

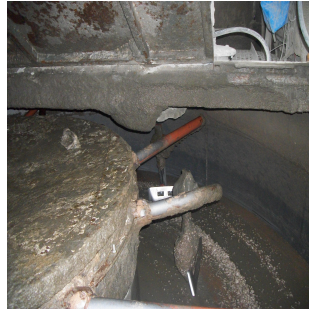
During his work in the restricted space within the mixer he did not realise that the waterproofs had become torn allowing the cement rich water and material to soak through on to his skin. It was only after exiting the mixer that he became aware of the problem and discovered he had suffered a first degree chemical burn to his lower back.

Mixer Interior

- Methods of work should be in place that minimise the risk of such burns.
- All relevant personnel should be trained in the risk of chemical / cementitious burns and the precautions that must be applied.

- Always wear the PPE required as set out in the Safe System of Work/Safe Operating Procedure
- Always check the PPE you are going to wear before commencing any work.
