Articulated Dumper Cab Overturn

LOCATION:	CONSTRUCTION/DELIVERY SITE	ALERT STATUS:	Normal
ACTIVITY:	PRODUCTION AND PROCESSING	DATE ISSUED:	16/08/2011
SUB ACTIVITY:	AGGREGATE PROCESSING	INCIDENT No:	00298

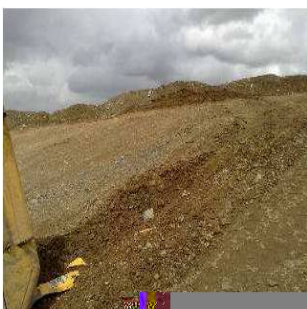
Slope

Whilst attempting to reverse down the slope the driver had his cab angled at 90 degrees to the trailer section which was positioned down the slope. Due to the width of the flat area at the top of the slope and the area being driven and turned on several times, depressions had appeared.

The front left hand side wheels were just off the flat area and on to the slope. The front left wheel went into a depression causing the cab to dip, due to this the weight of the rear body and its load caused the rear to drag the cab over and then slide approx 6 metres down the slope.

- the tip area being a more suitable grade for the operation and the operation better planned
- a more stringent inspection regime of the tip area by site managers, supervisors and drivers
